Municipal Energy Resilience Program Window Assessment for Memorial Hall Wilmington, Vermont

Prepared for:
Town of Wilmington
Vermont Division for Historic Preservation

June 18, 2025

Memorial Hall Window Assessment

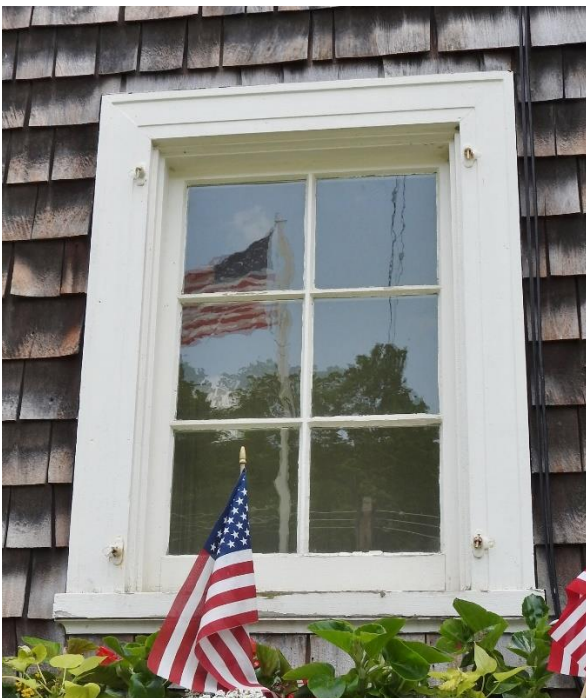
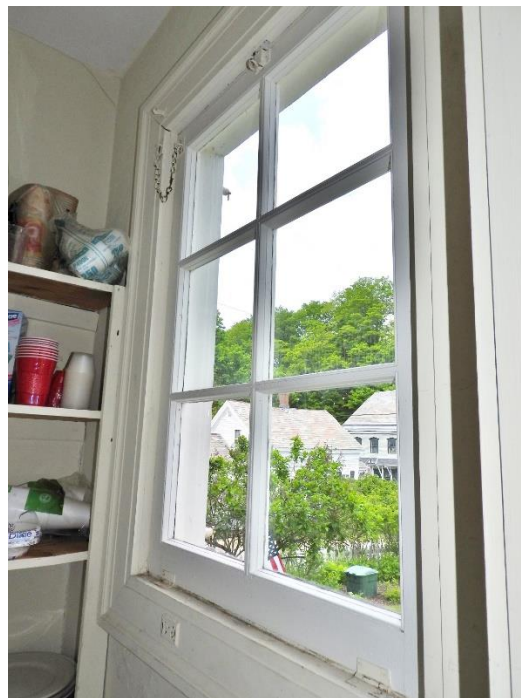
Window 1. This hopper window is in good condition, with areas of peeling paint, and the exterior glazing may need replacement.

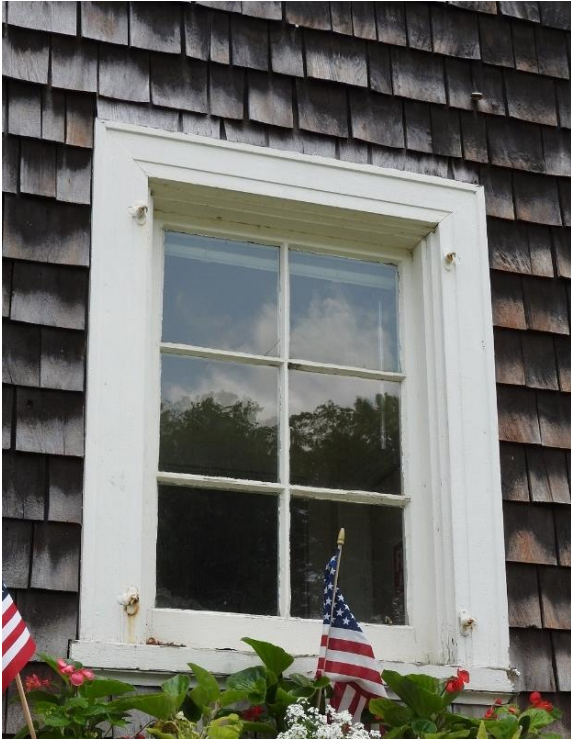
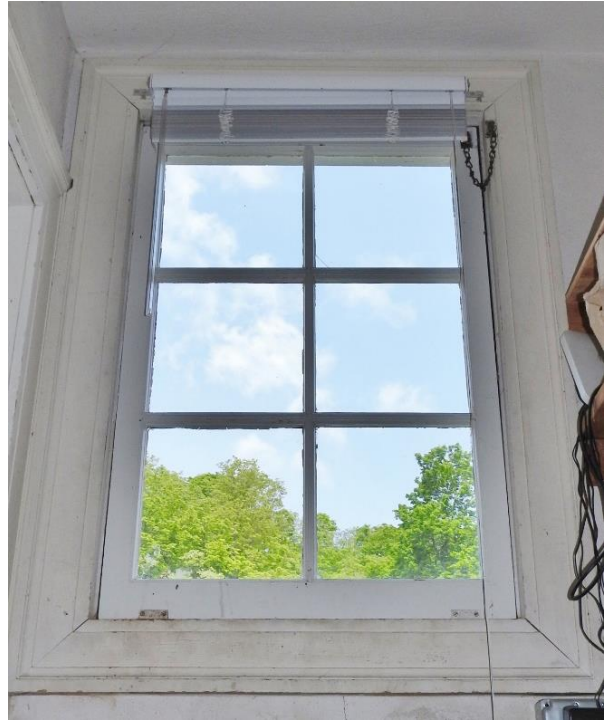
Window 2. This hopper window is in good condition, with areas of peeling paint, and the exterior glazing may need replacement.

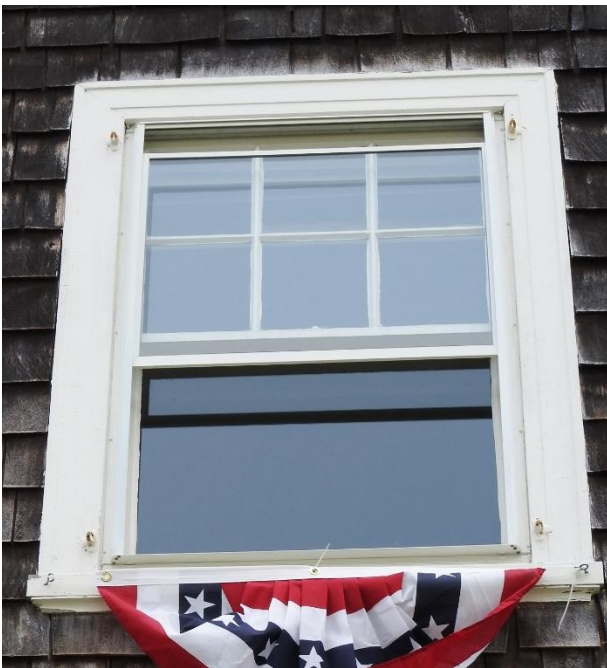
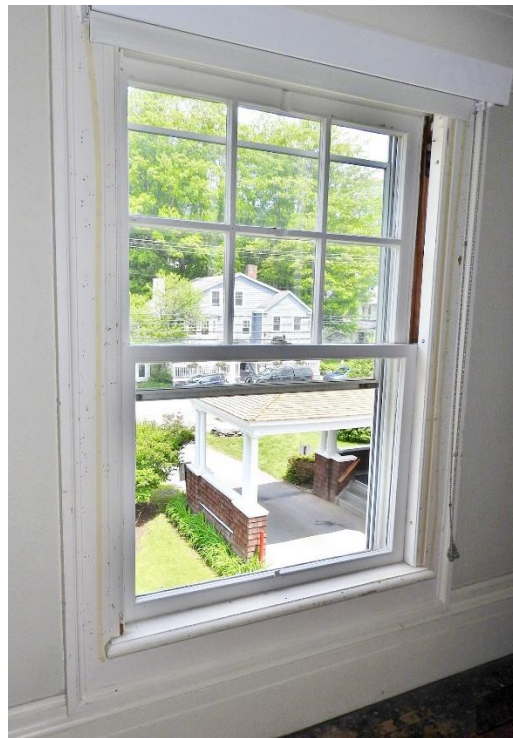
Window 3. This double-hung window is in good condition, with areas of peeling paint, and the exterior glazing may need replacement. One sash of the storm window is missing.

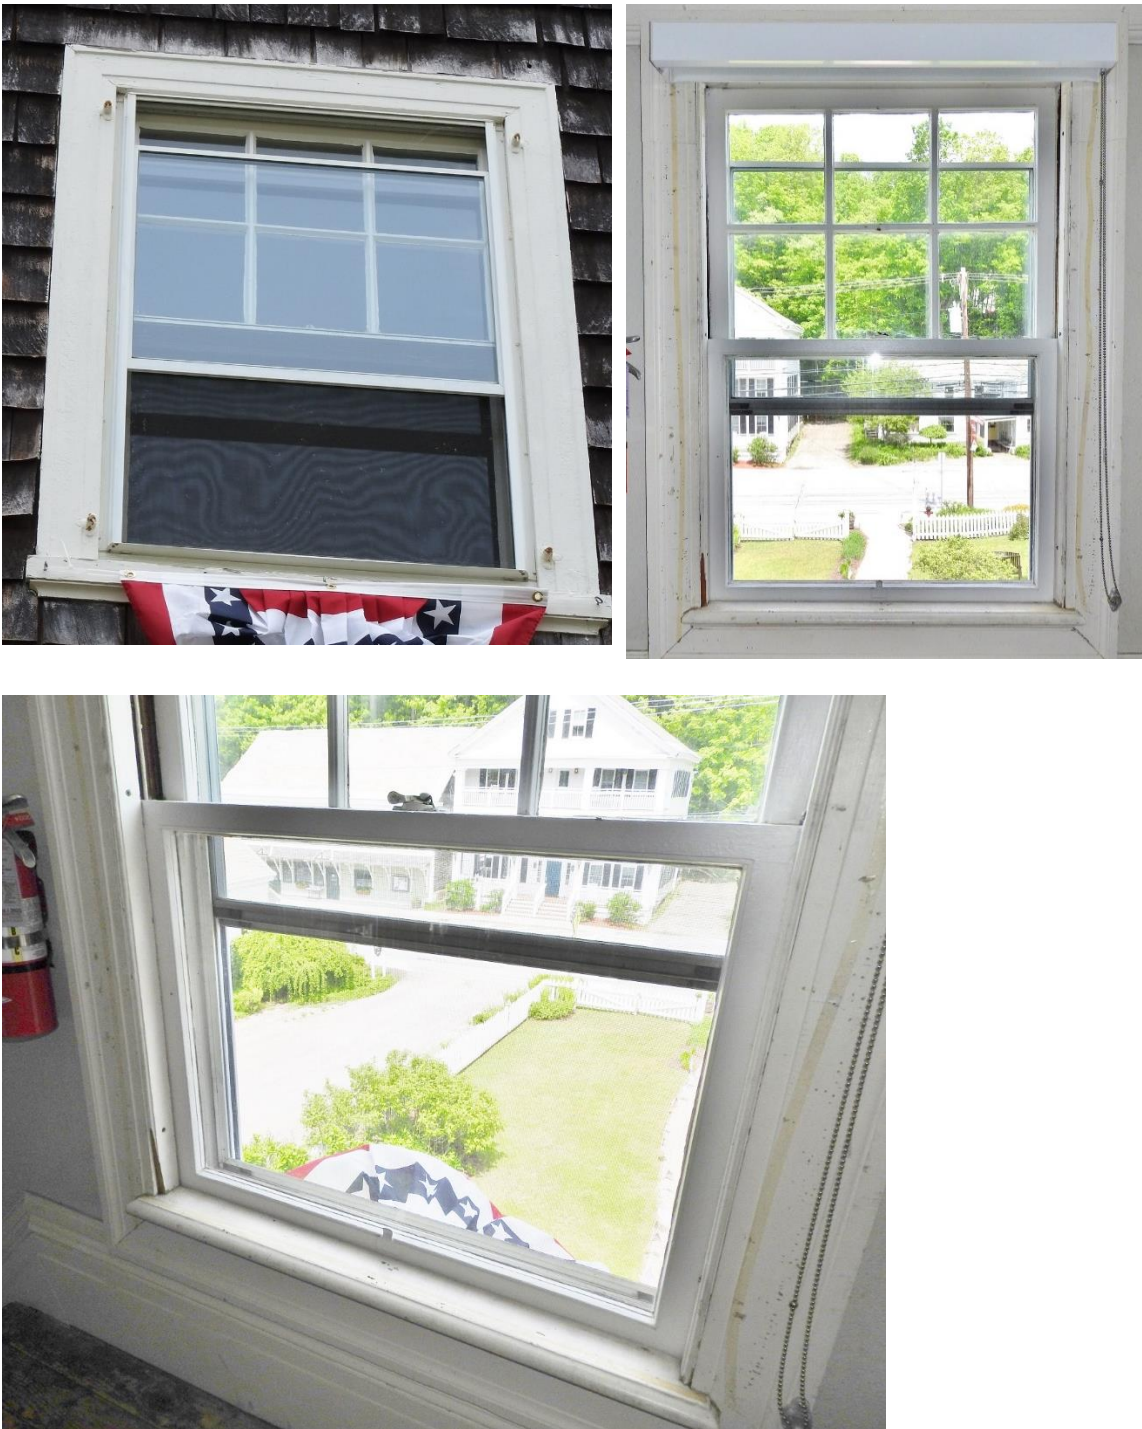
Window 4. This double-hung window is in good condition, with areas of peeling paint, and the exterior glazing may need replacement.

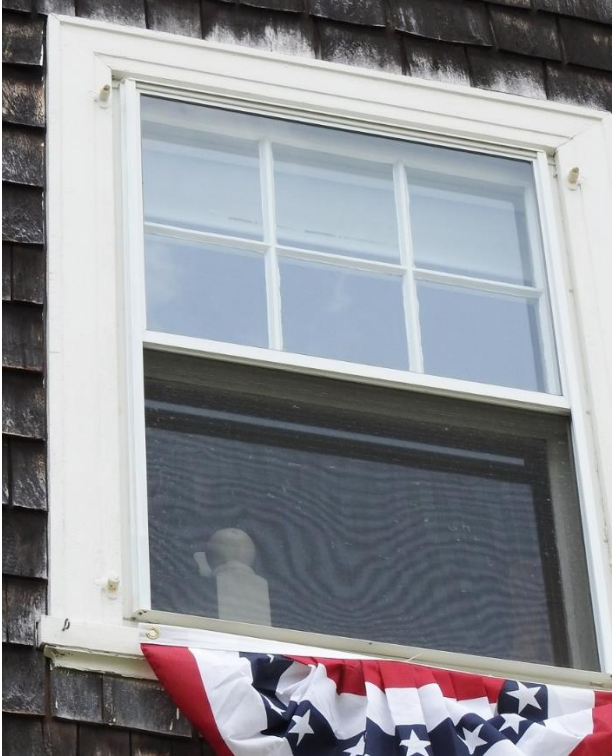
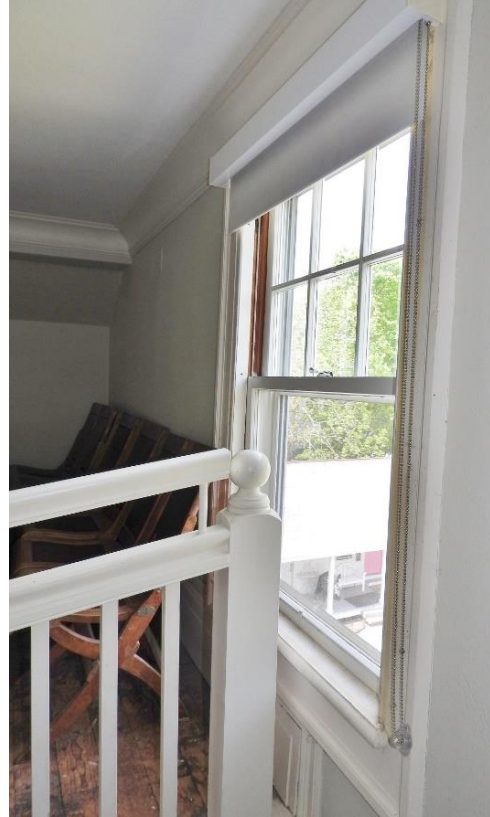
Window 5. This double-hung window is in good condition, with areas of peeling paint, and the exterior glazing may need replacement.

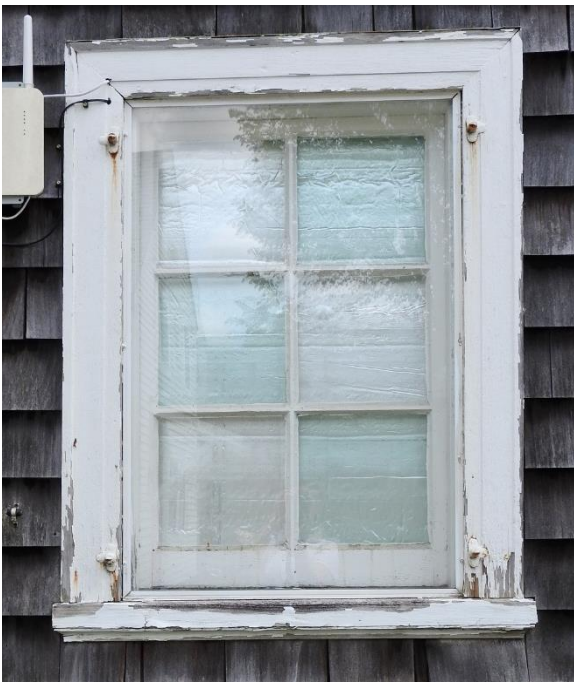
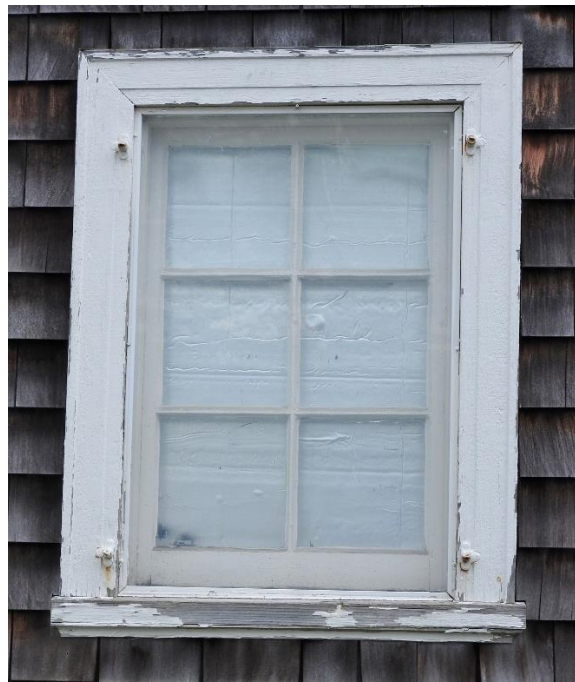
Windows 6 and 7. These hopper windows have areas of peeling paint, have been fixed closed, and the exterior glazing may need replacement. They are blocked on the interior with insulation.

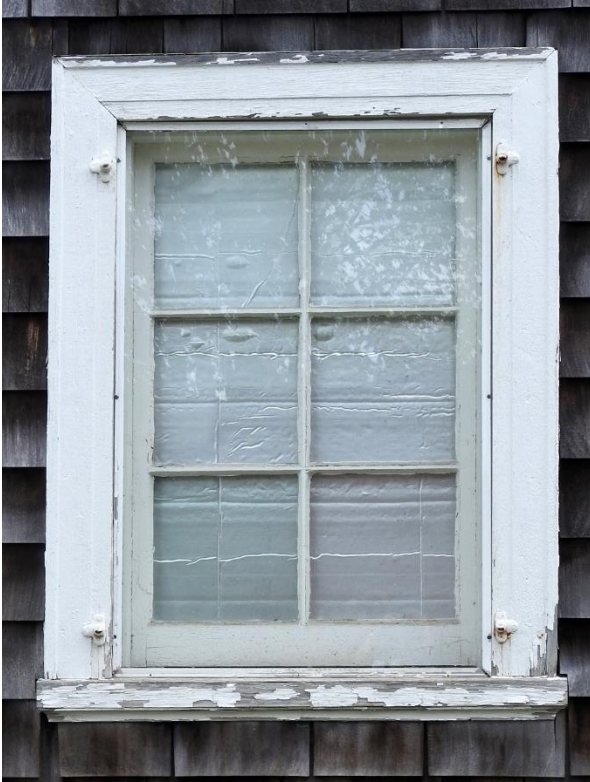
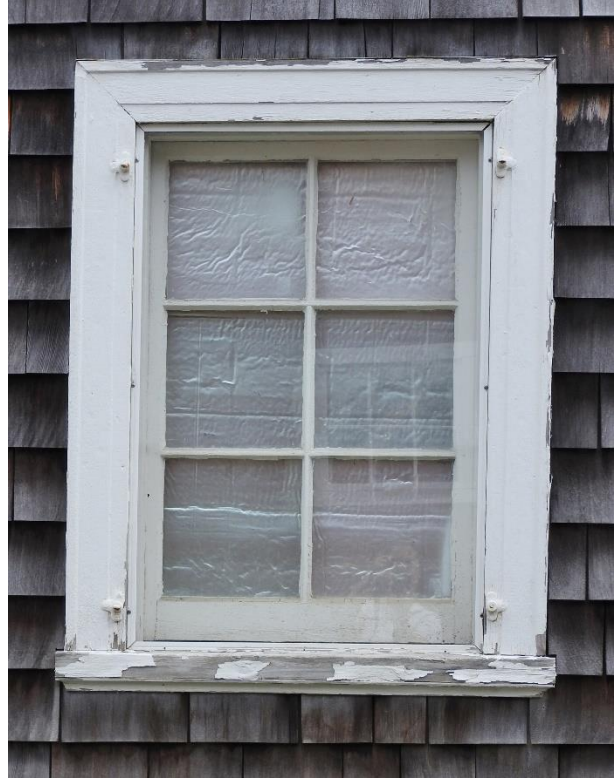
Windows 8 and 9. These hopper windows have areas of peeling paint, have been fixed closed, and the exterior glazing may need replacement. They are blocked on the interior with insulation.

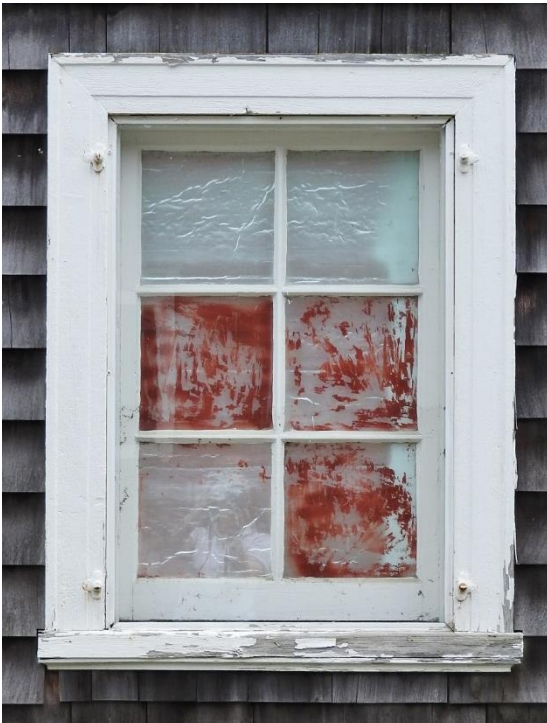
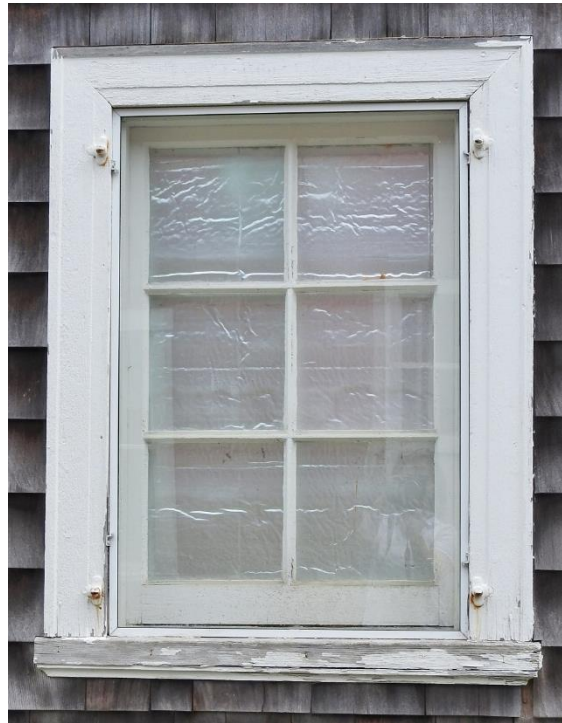
Windows 10 and 11. These hopper windows have areas of peeling paint, have been fixed closed, and the exterior glazing may need replacement. They are blocked on the interior with insulation.

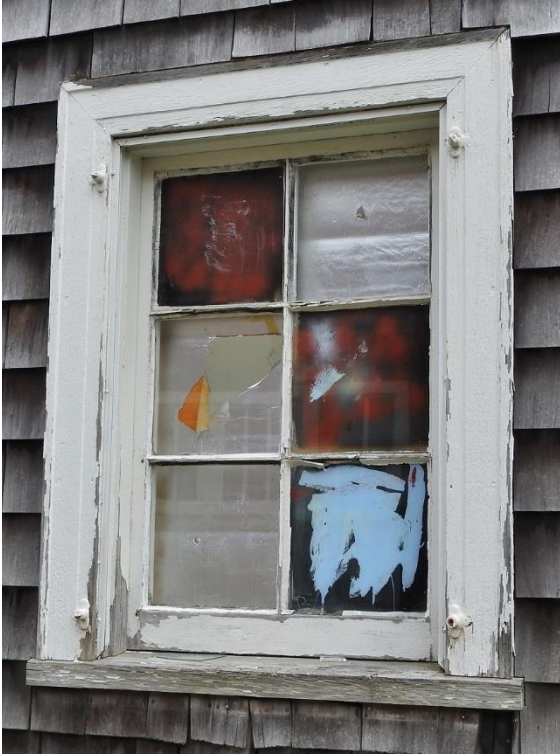
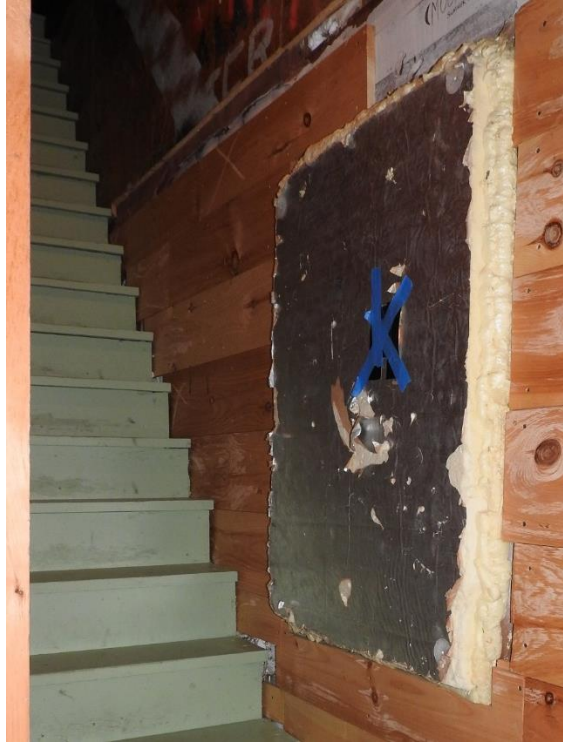
Window 12. This hopper window has areas of peeling paint, has been fixed closed, and the exterior glazing may need replacement. It is blocked on the interior with insulation.

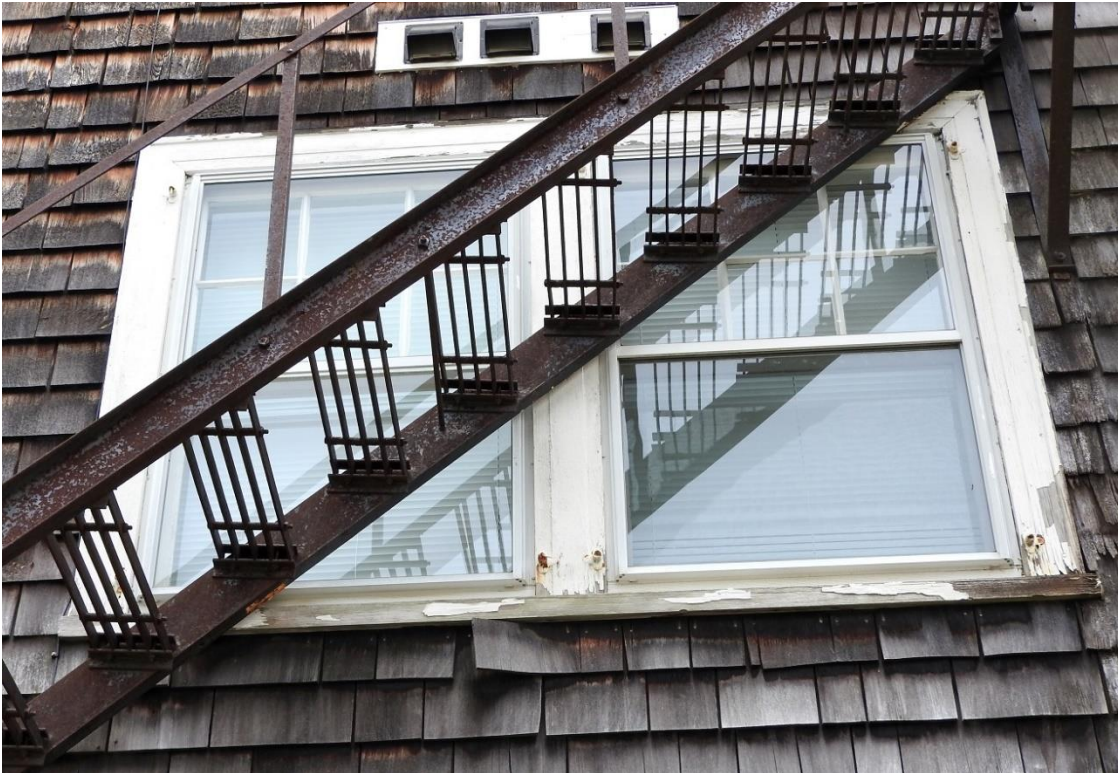
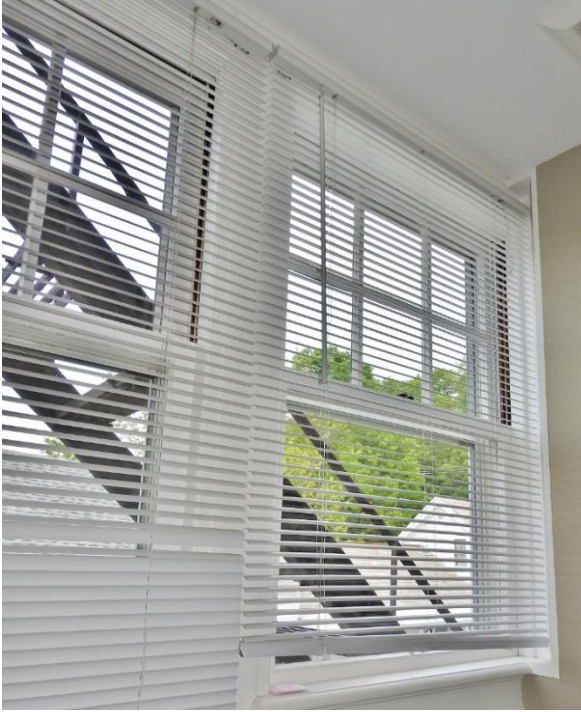
Windows 13 and 14

Windows 13 and 14. These double-hung windows are in good condition, have areas of peeling paint, and the exterior glazing may need replacement.

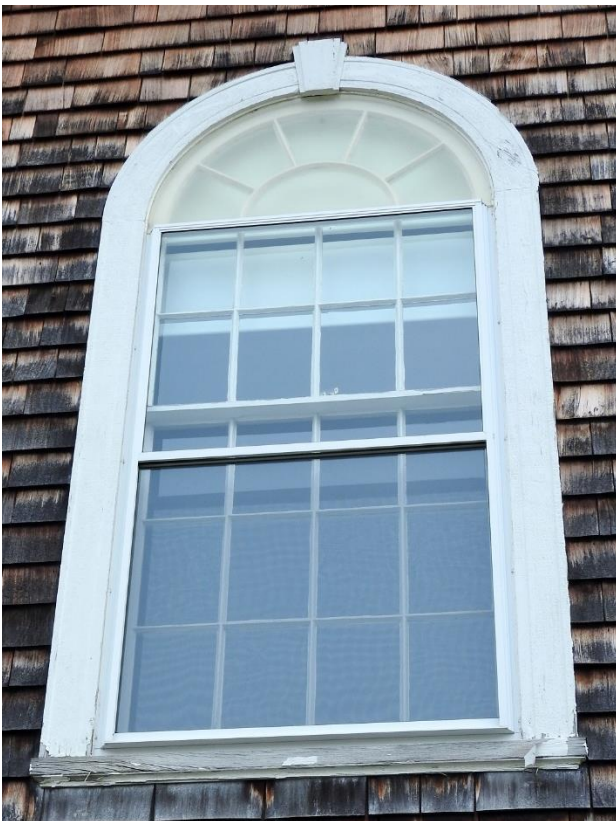
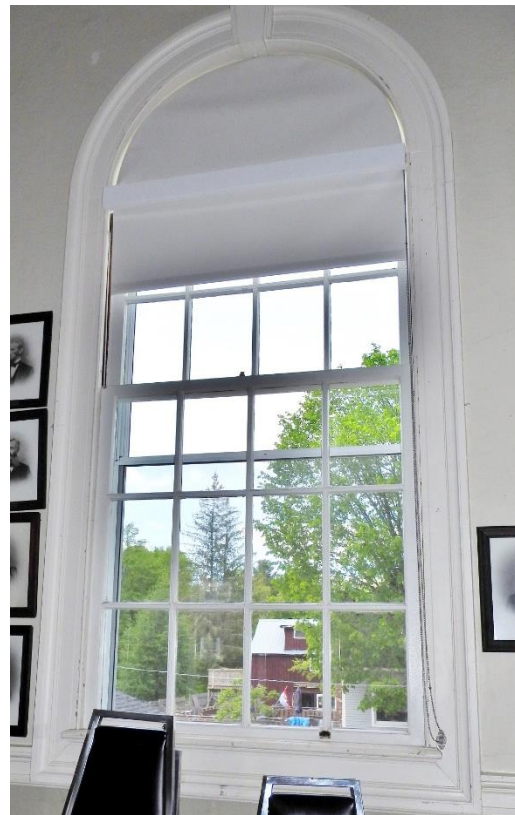
Window 15. This double-hung window with fanlight is in good condition, with areas of peeling paint, and the exterior glazing may need replacement. Note how the meeting rails of the wood windows and storm window do not align.

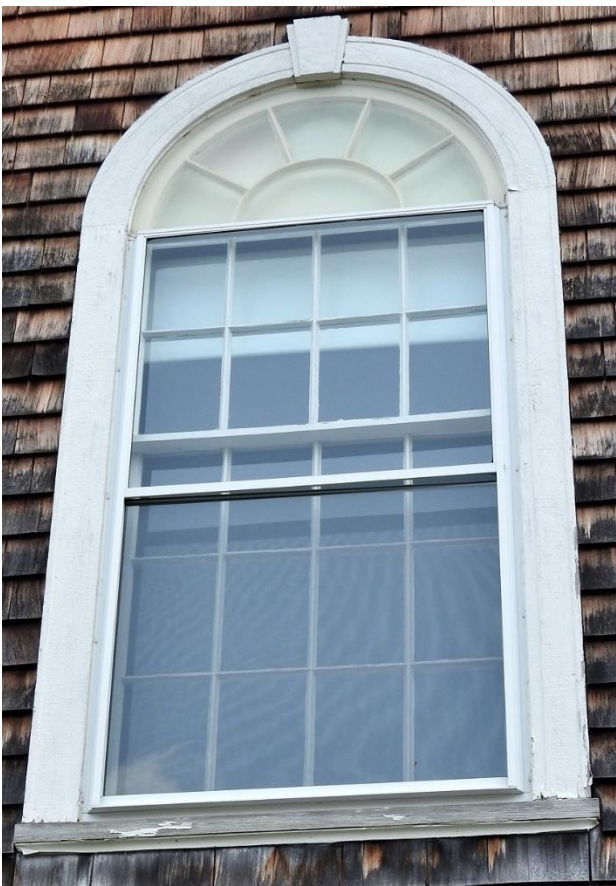
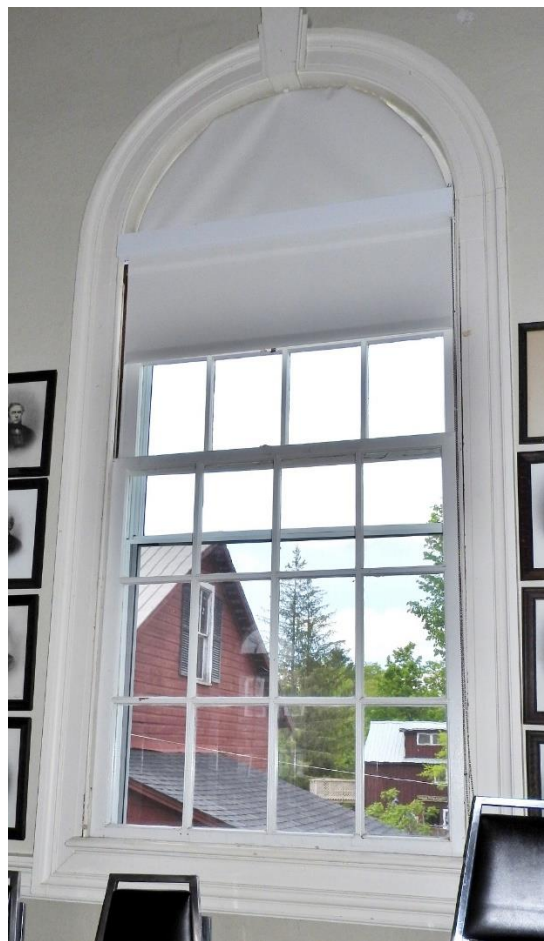
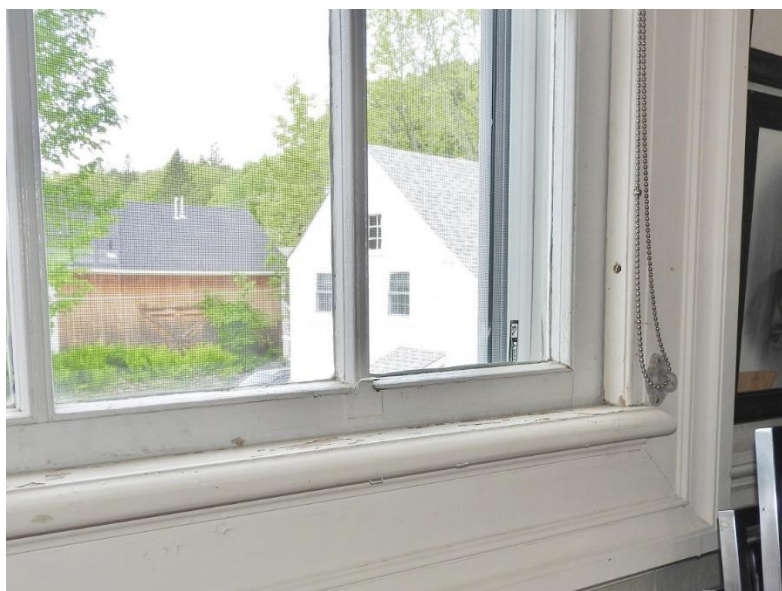
Window 16. This double-hung window with fanlight is in good condition, with areas of peeling paint, and the exterior glazing may need replacement. Note how the meeting rails of the wood windows and storm window do not align.

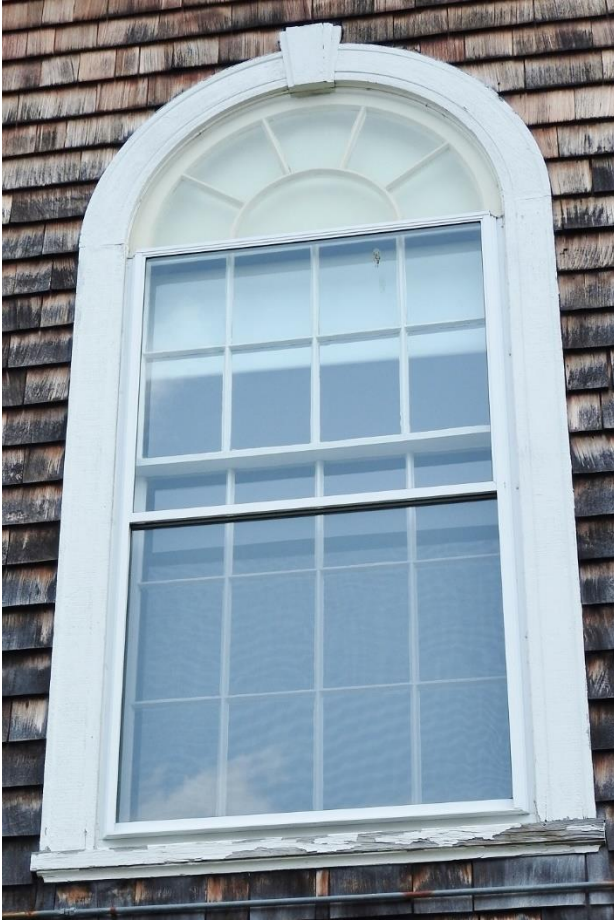
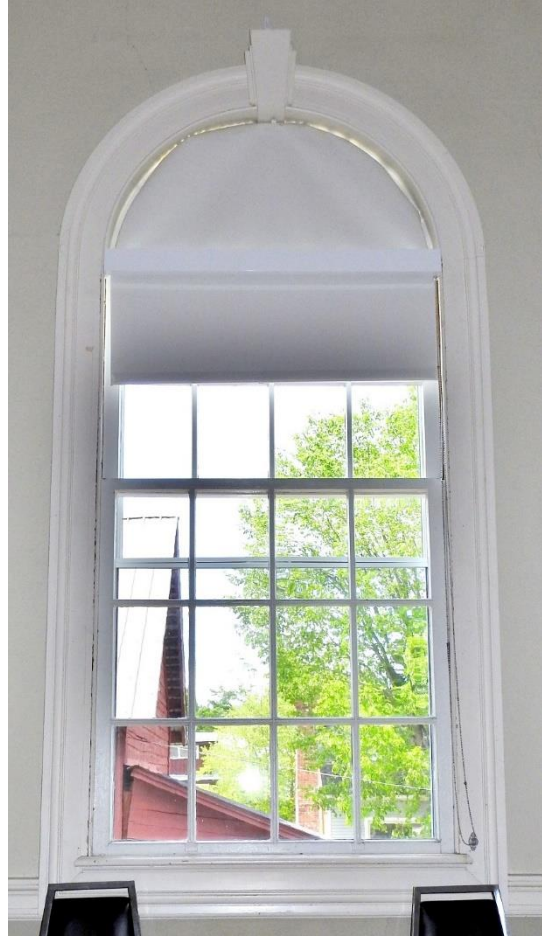
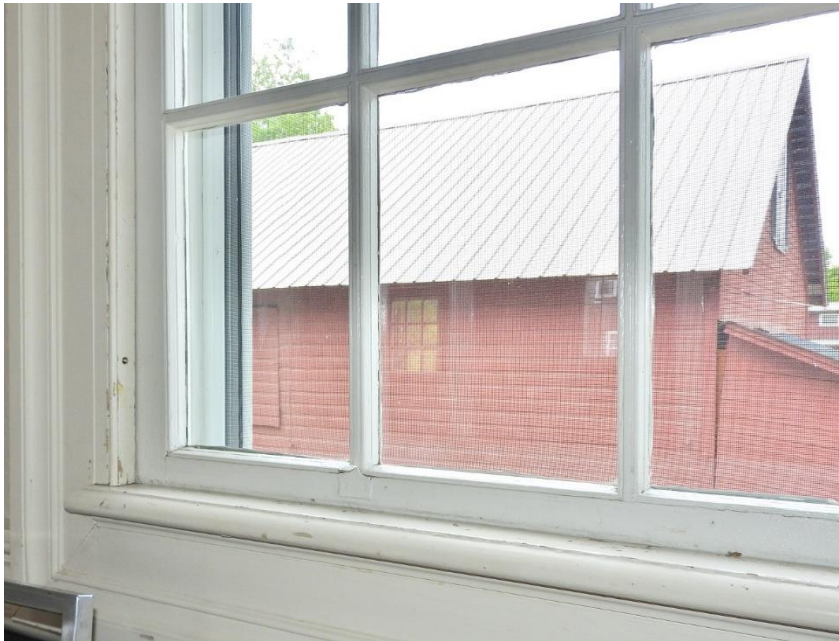
Window 17. This double-hung window with fanlight is in good condition, with areas of peeling paint, and the exterior glazing may need replacement. Note how the meeting rails of the wood windows and storm window do not align.

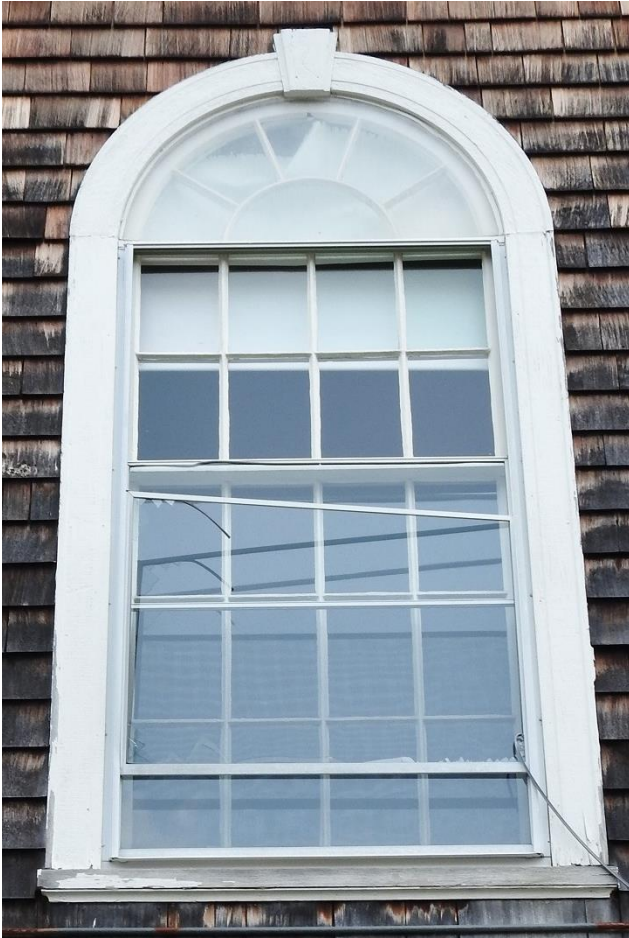
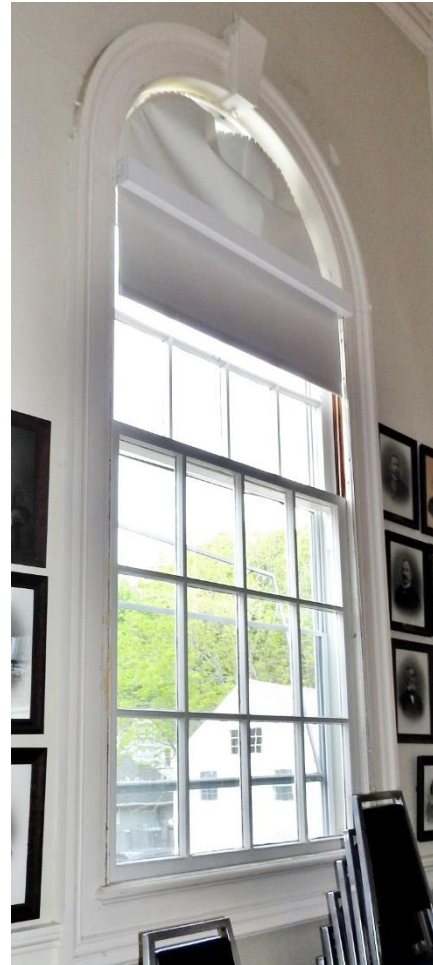
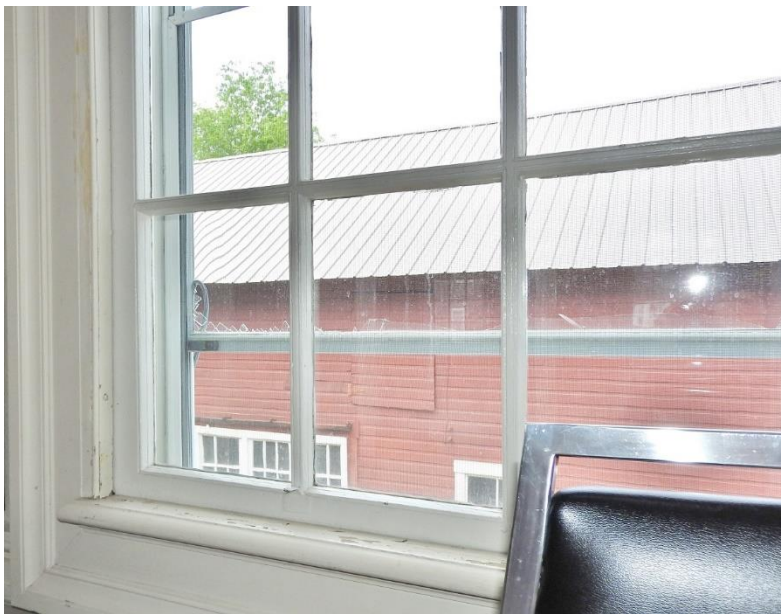
Window 18. This double-hung window with fanlight is in good condition, with areas of peeling paint, and the exterior glazing may need replacement. Note how the meeting rails of the wood windows and storm window do not align, and one storm sash is broken.

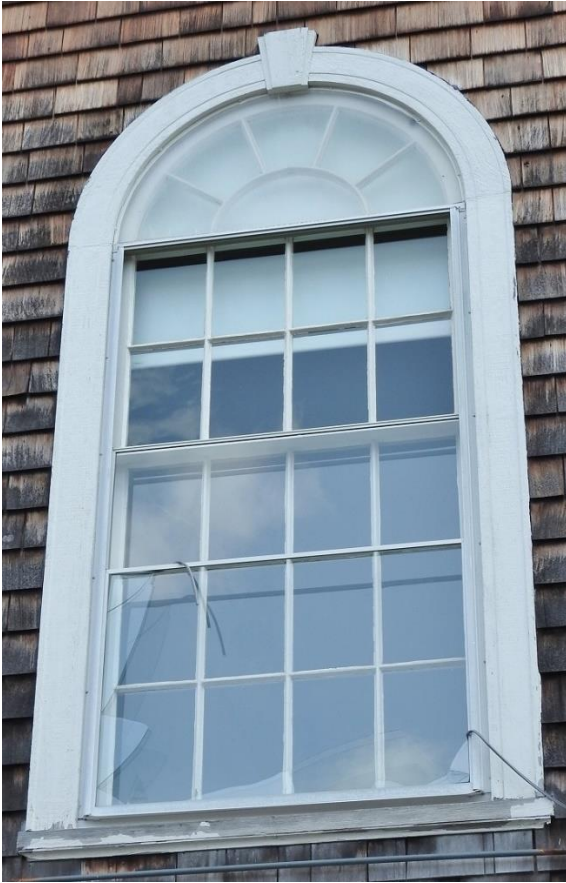
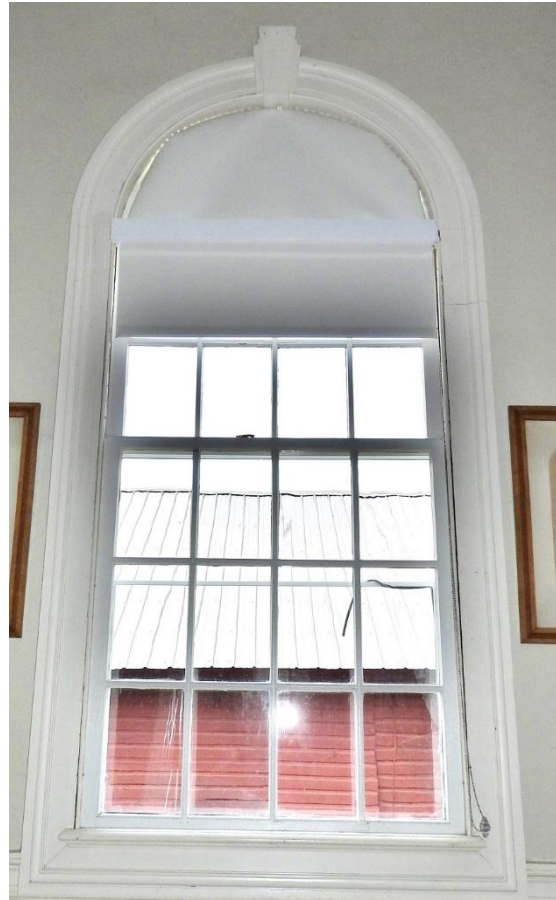
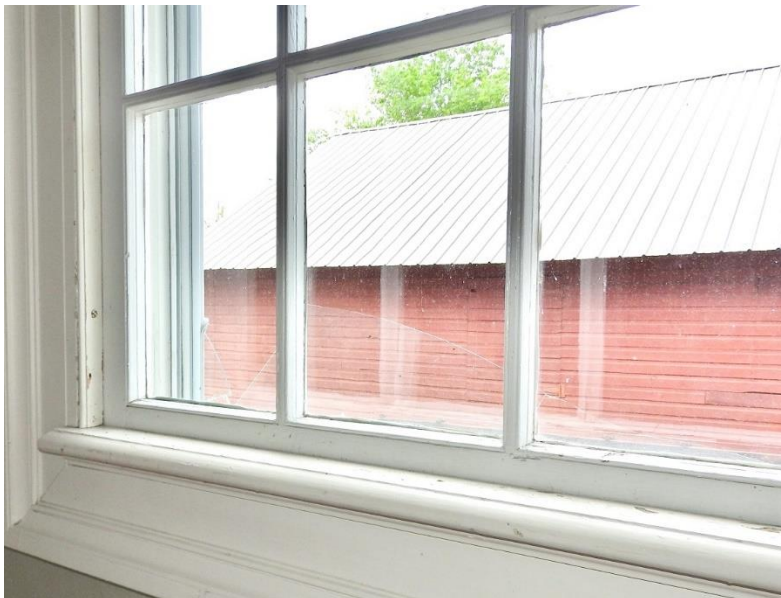
Window 19. This double-hung window is in good condition, with areas of peeling paint, and the exterior glazing may need replacement. Note how the meeting rails of the wood windows and storm window do not align, and one storm sash is broken.

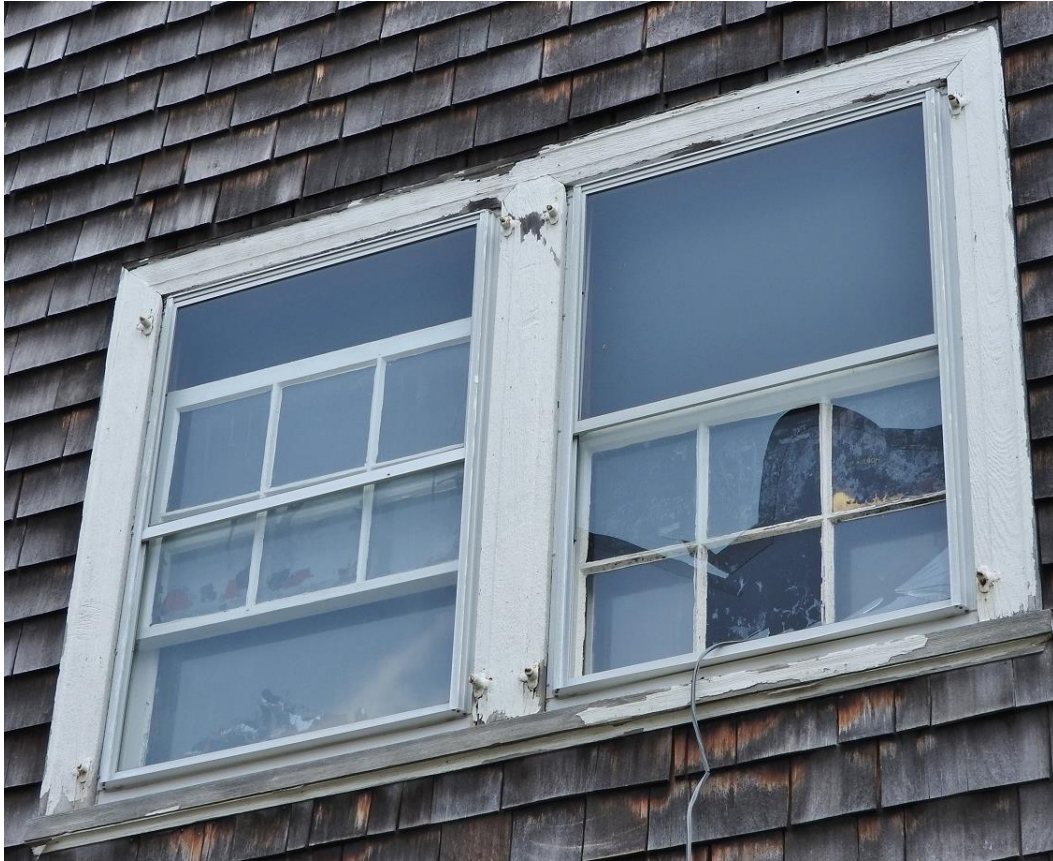
Windows 20 and 21. These double-hung windows are not properly closed, have deteriorated glazing, and broken storm sash. They are blocked on the interior.

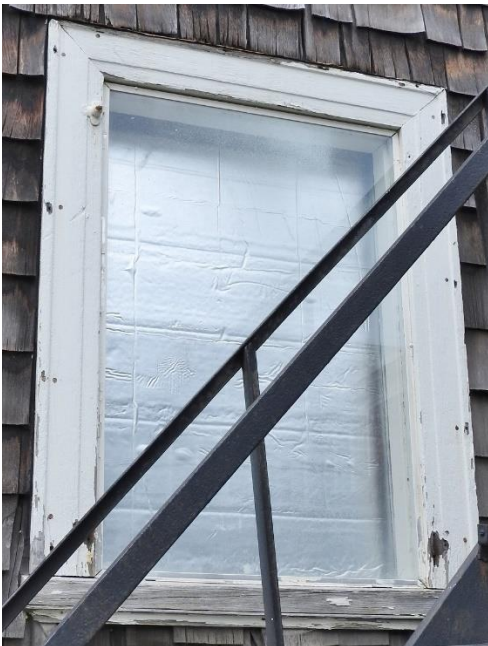
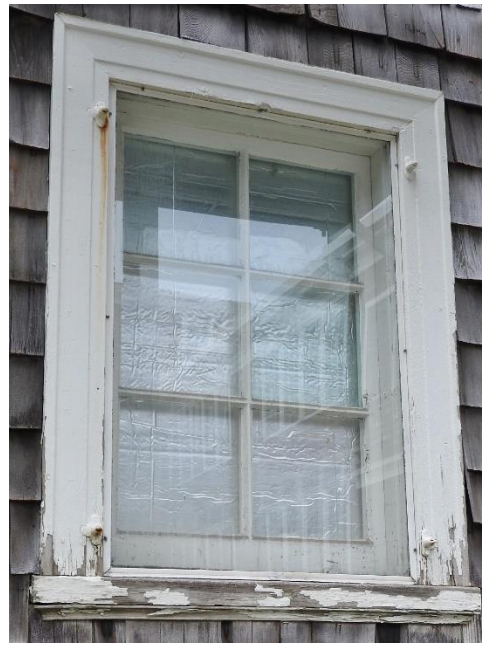
Windows 22 and 23. These hopper windows have areas of peeling paint, have been fixed closed, and the exterior glazing may need replacement. They are blocked on the interior with insulation.

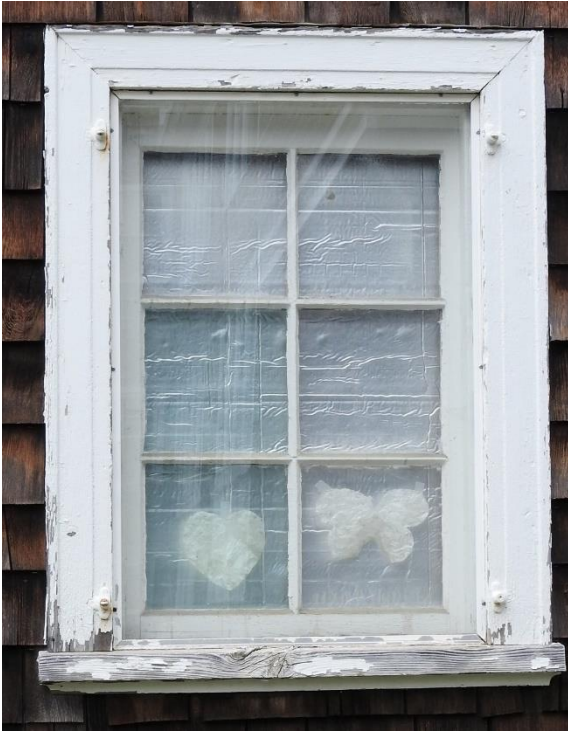
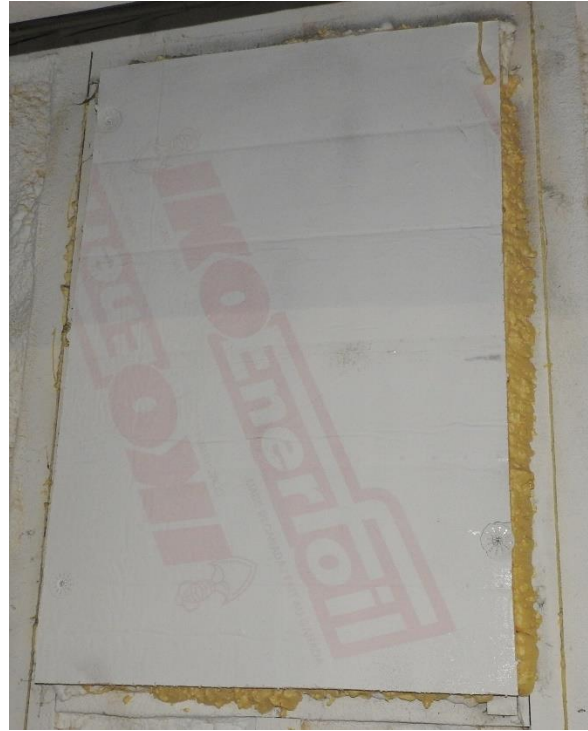
Window 24. This hopper window has areas of peeling paint, has been fixed closed, and the exterior glazing may need replacement. It is blocked on the interior with insulation.

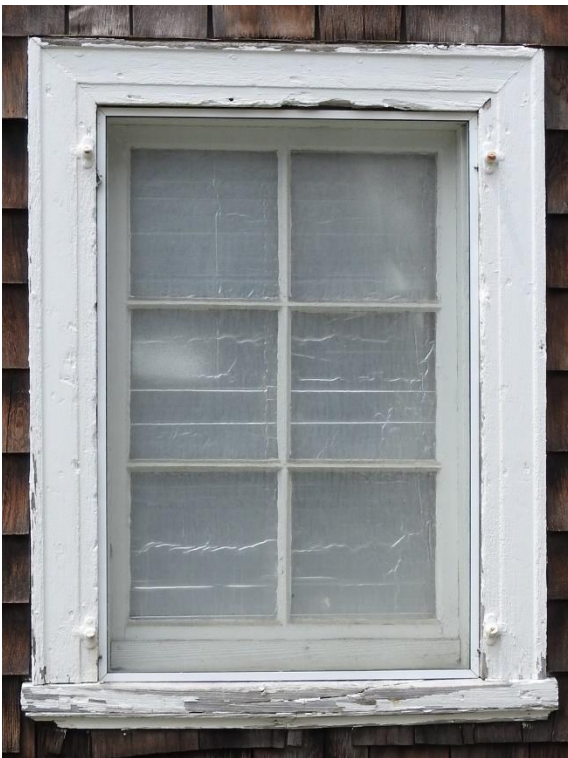
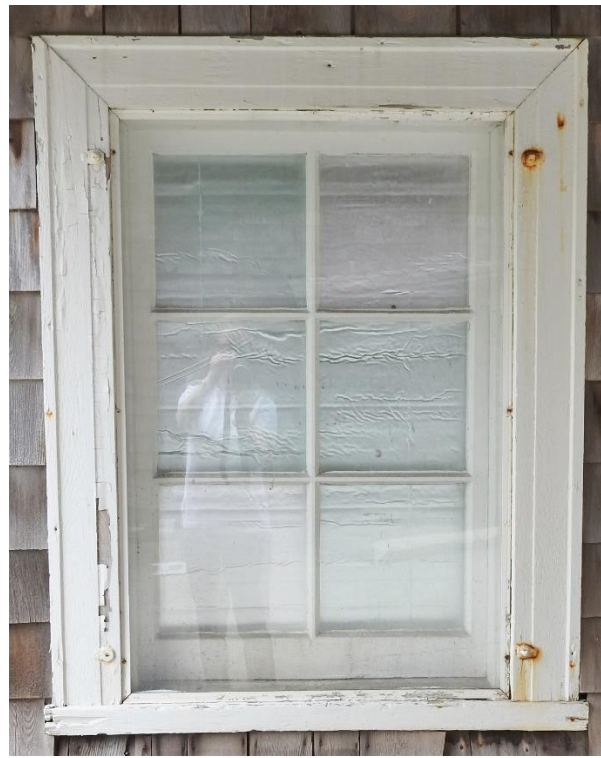
Windows 25 and 26. These hopper windows have areas of peeling paint, have been fixed closed, and the exterior glazing may need replacement. They are blocked on the interior with insulation.

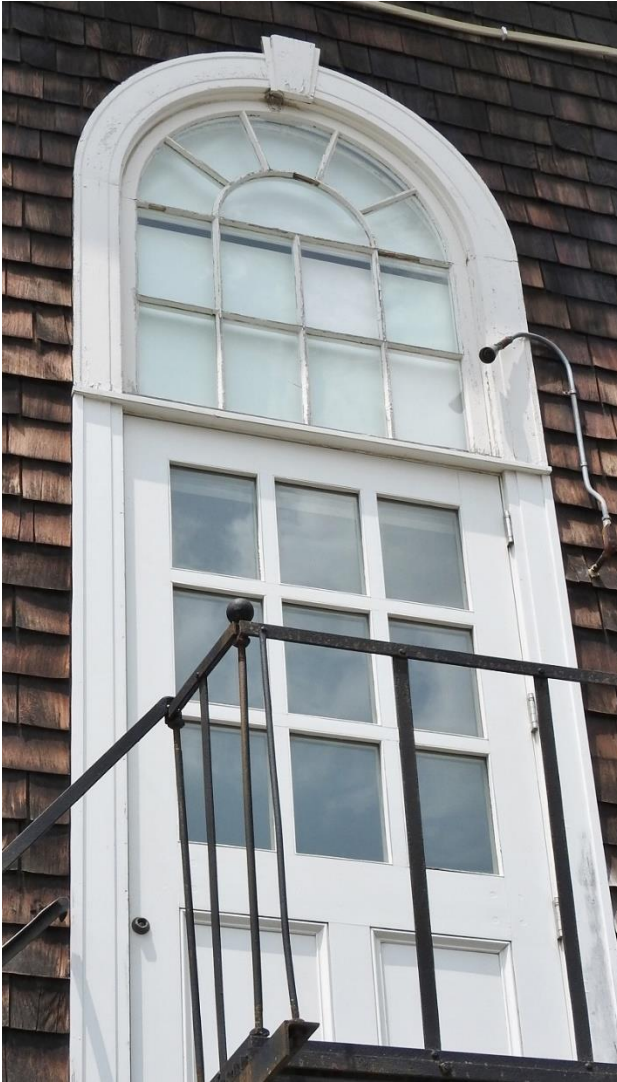
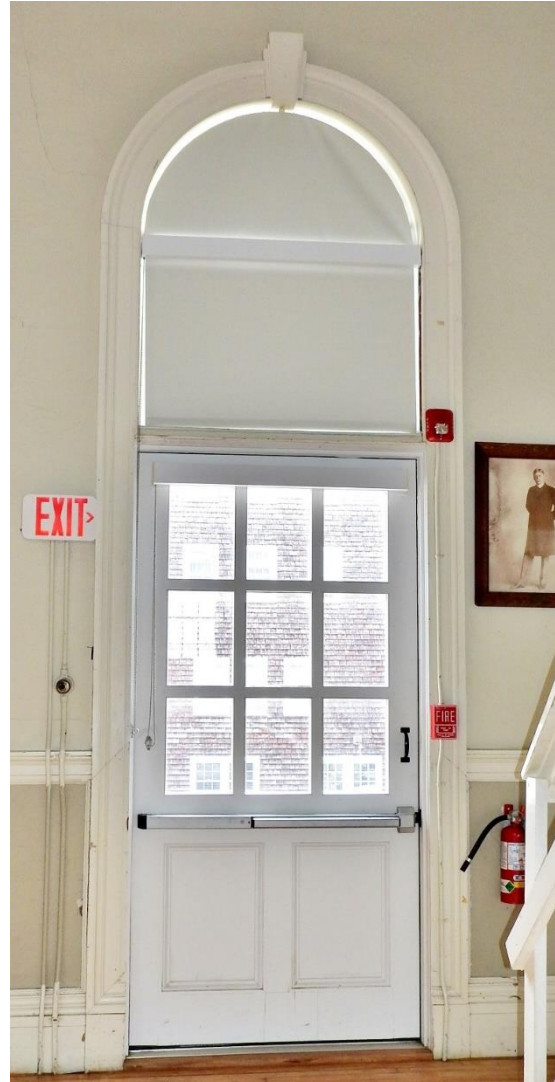
Window 27. This window and fanlight surmount a door. They are in good condition, with areas of peeling paint, and the exterior glazing may need replacement.
