Municipal Energy Resilience Program Window Assessment for Memorial Hall Wilmington, Vermont

Prepared for:
Town of Wilmington
Vermont Division for Historic Preservation

June 18, 2025

Memorial Hall Window Assessment

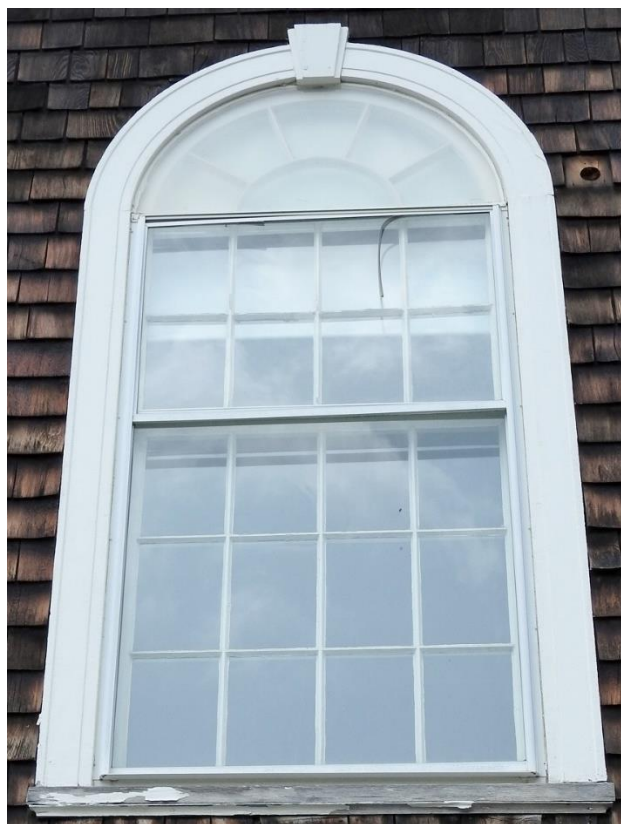
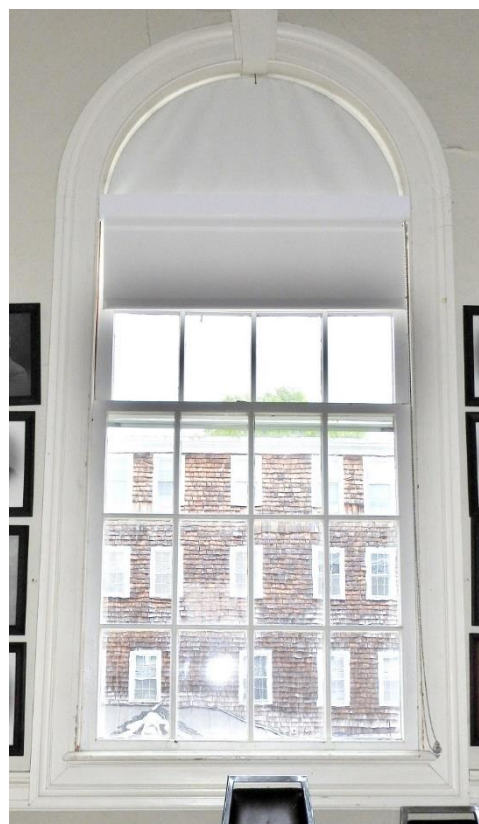
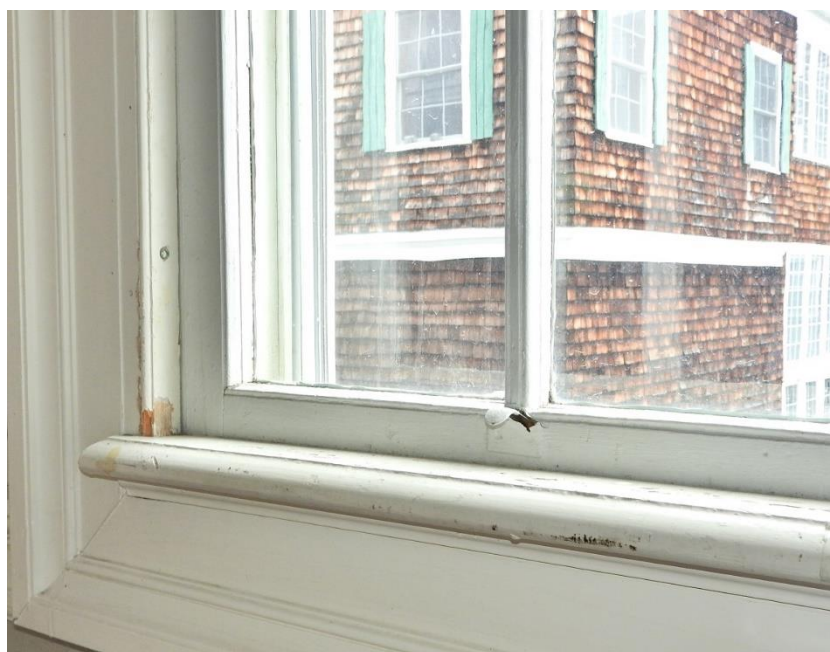
Window 28. This double-hung window with fanlight is in good condition, with areas of peeling paint, and the exterior glazing may need replacement. On this side of the building, the meeting rails of the storm sash align with the wood windows, but some sash are out of alignment and there is loose weather stripping.

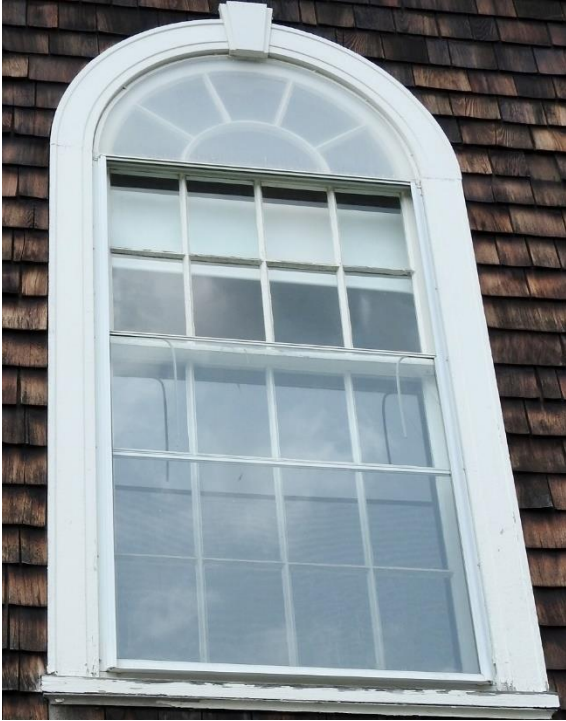
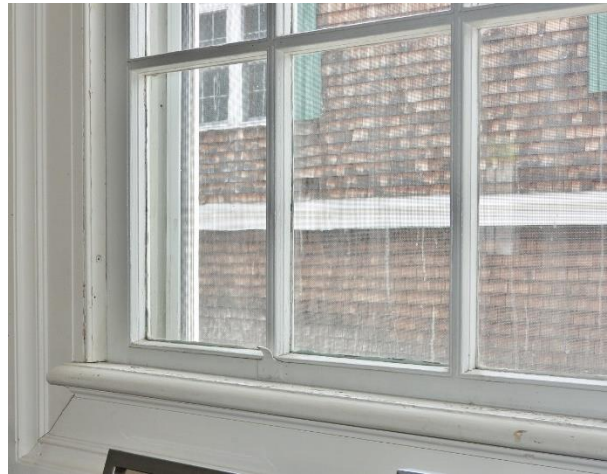
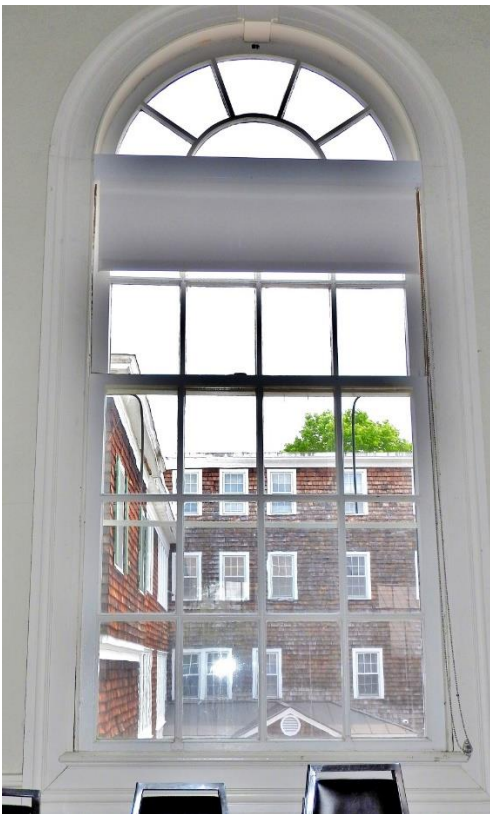
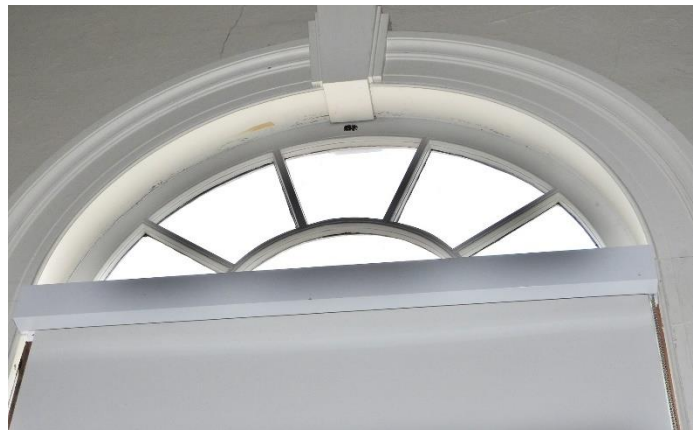
Window 29. This double-hung window with fanlight is in good condition, with areas of peeling paint, and the exterior glazing may need replacement. On this side of the building, the meeting rails of the storm sash align with the wood windows, but some sash are out of alignment and there is loose weather stripping.

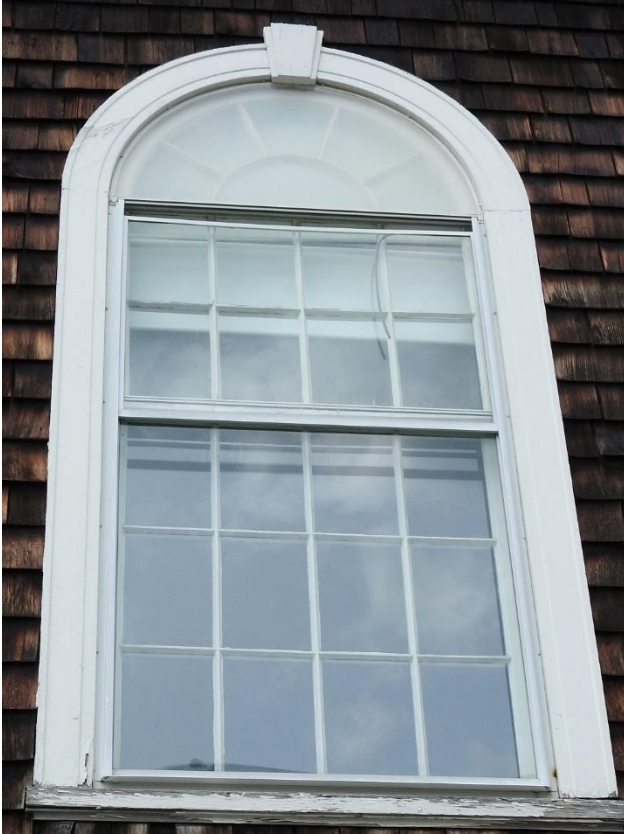
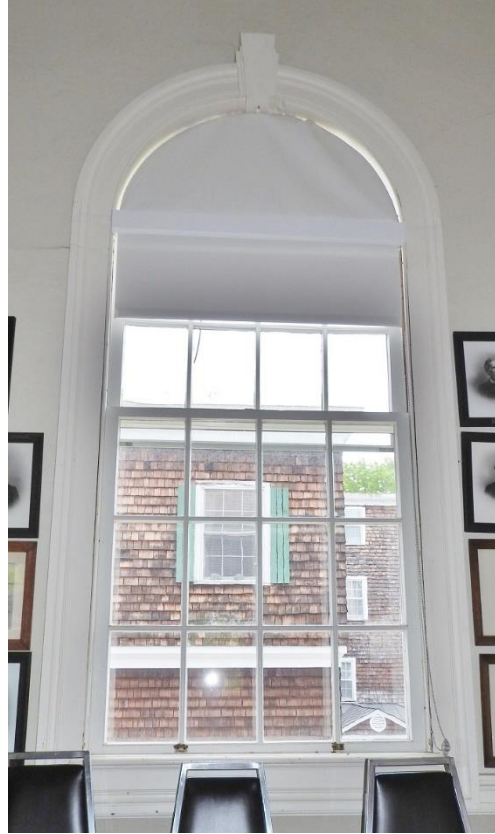
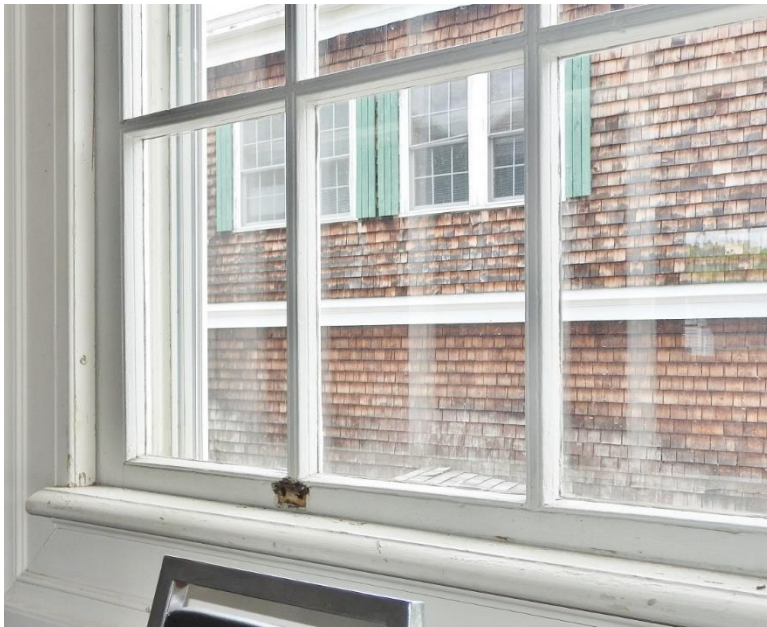
Window 30. This double-hung window with fanlight is in good condition, with areas of peeling paint, and the exterior glazing may need replacement. On this side of the building, the meeting rails of the storm sash align with the wood windows, but some sash are out of alignment and there is loose weather stripping.

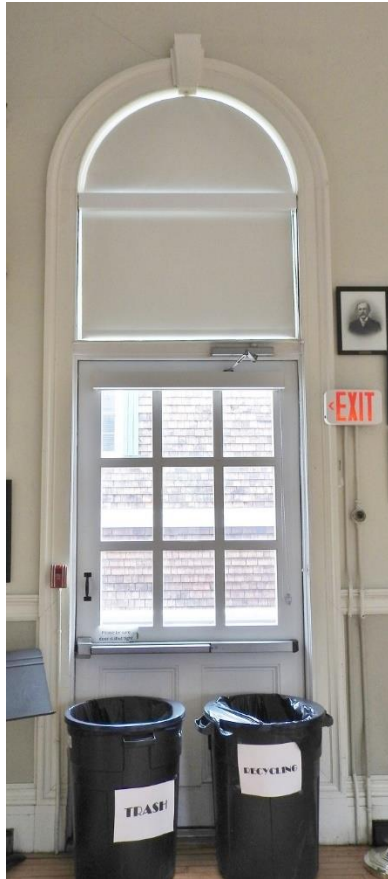
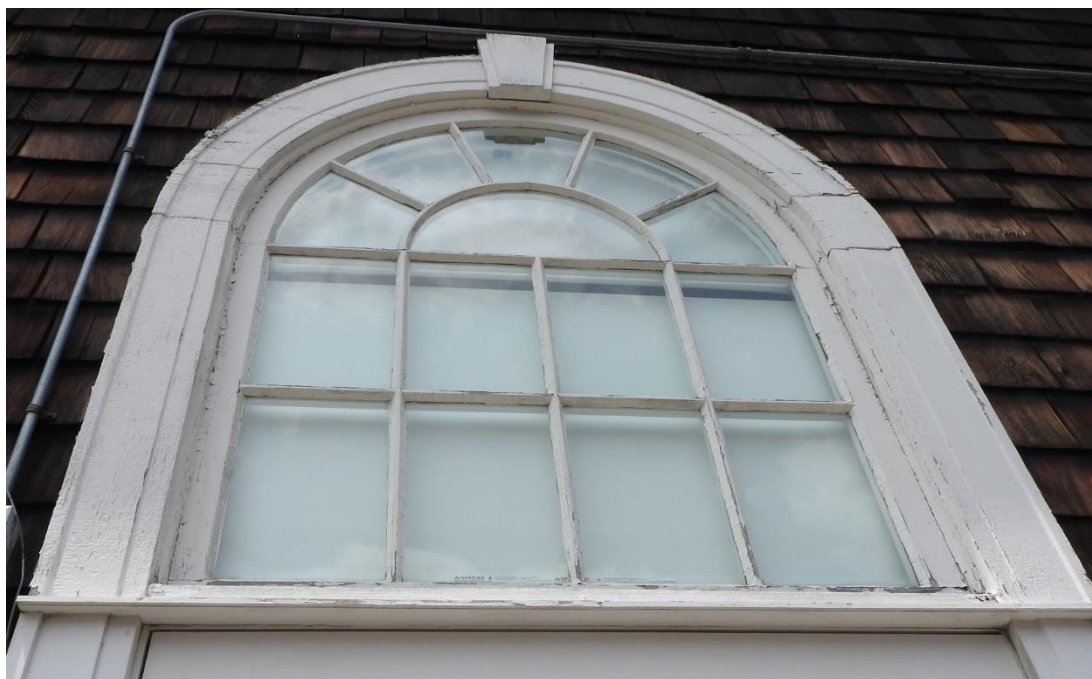
Window 31. This window and fanlight surmount a door. They are in good condition, with areas of peeling paint, and the exterior glazing needs replacement.

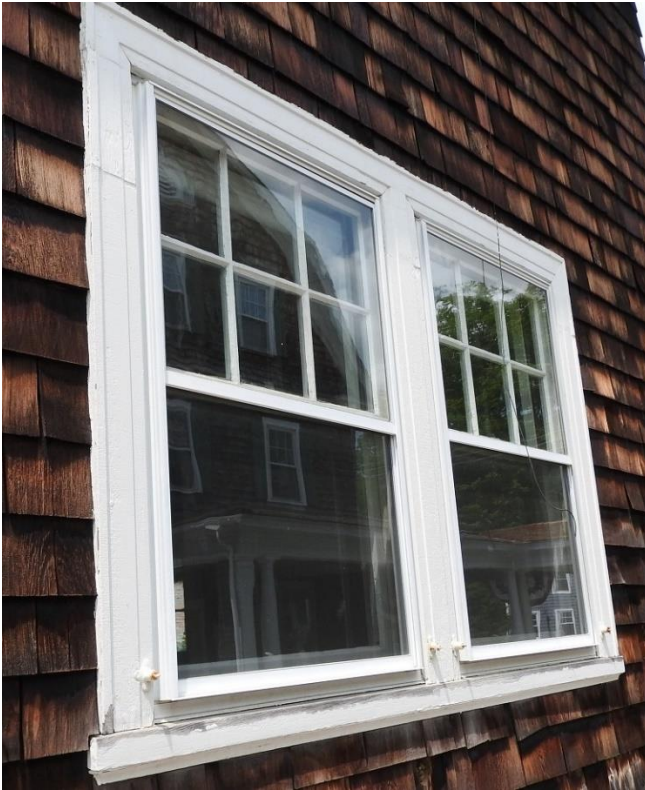
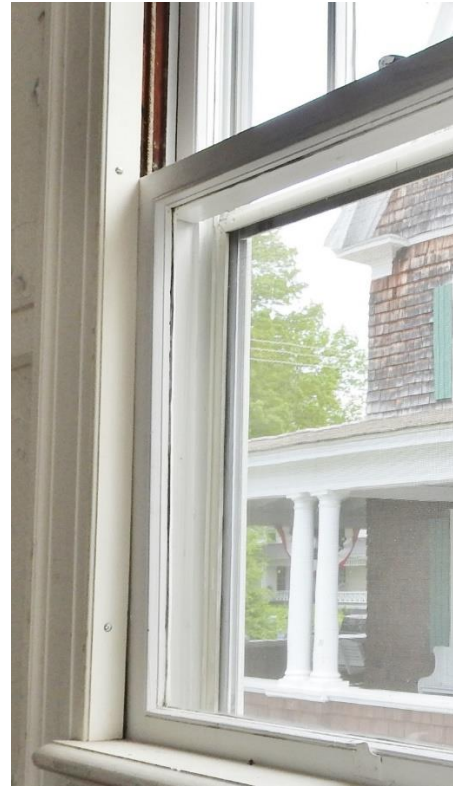
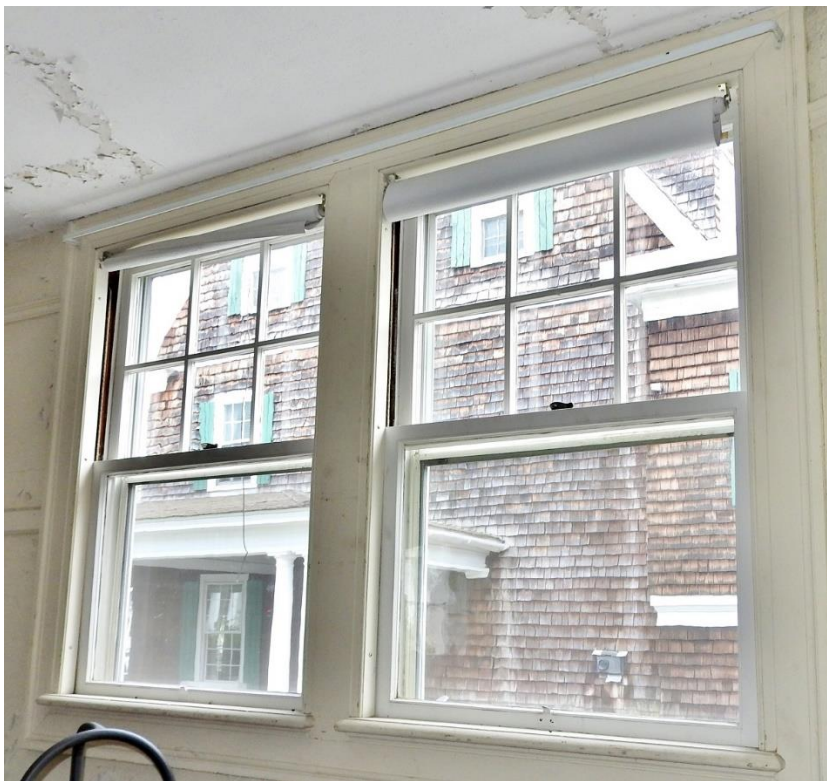
Windows 32 and 33. These double-hung windows are in good condition, have areas of peeling paint, and the exterior glazing may need replacement.

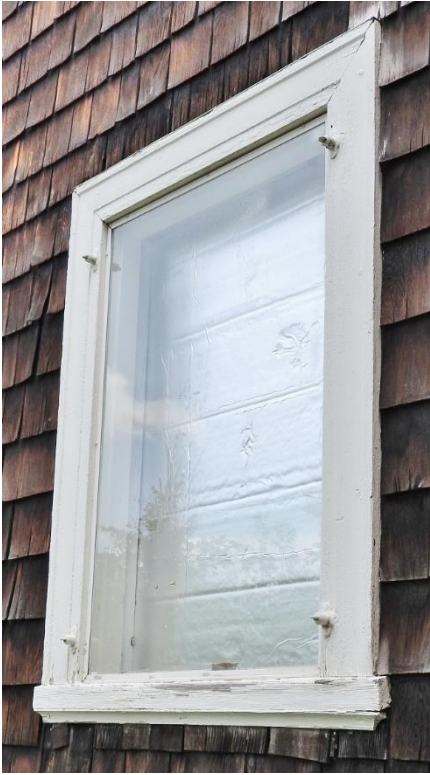
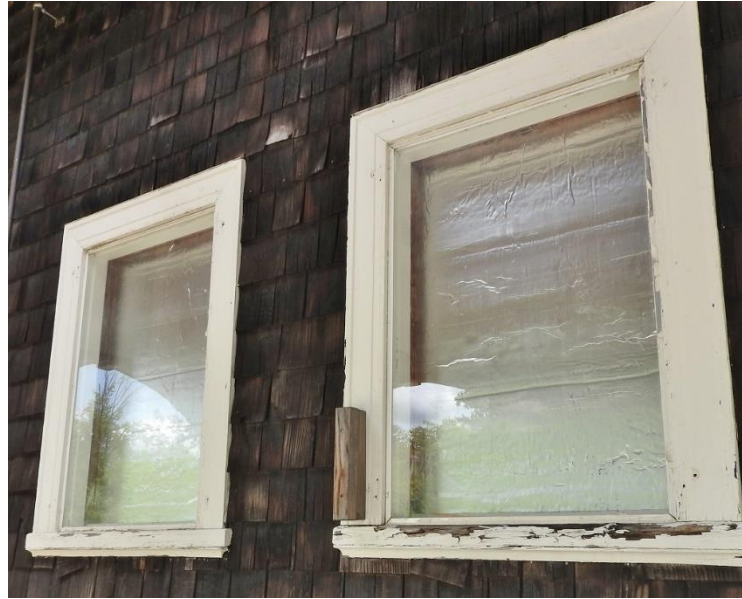
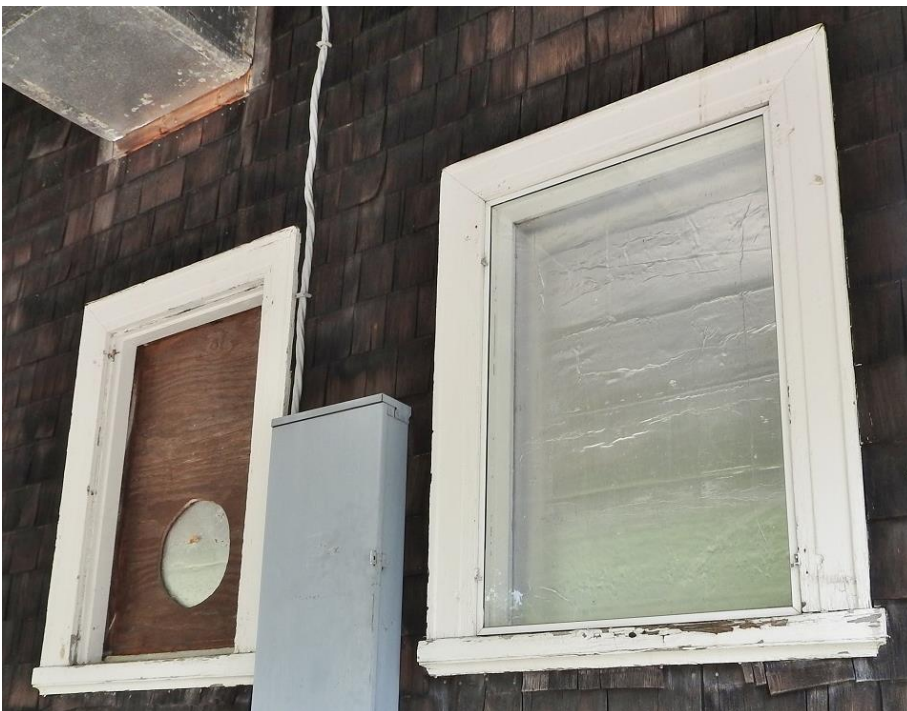
Windows 34, 35, 36, 37 and 38. These basement windows are in good condition, with areas of peeling paint. The glass pane of Window 37 has been removed. All of the windows are blocked on the interior with insulation.

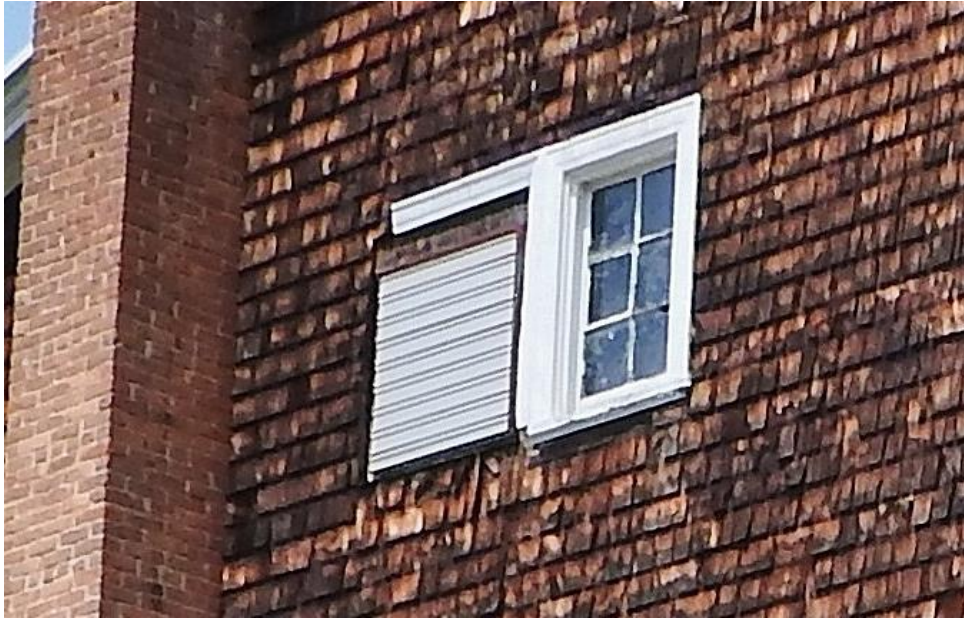
Window 39. This was originally a paired window. The remaining sash is in poor condition.
