# **LAKE RAPONDA, GREEN MOUNTAIN BEACH SHORELINE EROSION CONTROL 30% DESIGN REPORT**

Client: Windham County Natural Resources  
Conservation District

Consultant: DuBois & King, Inc.

Date of Report: October 9, 2024

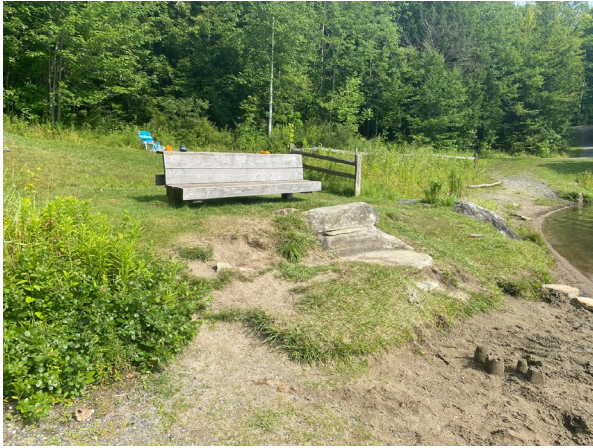
Infiltration steps are proposed between the vegetated buffers where there is currently a single bench. This will provide a safer path down to the beach, a place to sit, and without creating new impervious surface. They are proposed to be cut around existing stones which are an admired feature of beach goers.

Existing bench and boulders between vegetated buffers, site of proposed infiltration steps

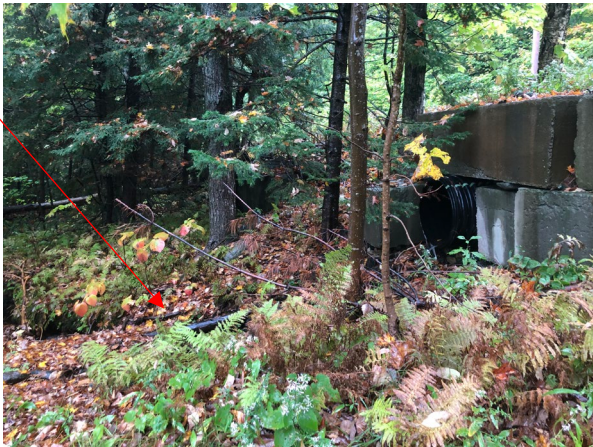
observed to have been dislodged (likely by people, not water) and a significant sediment plume was observed entering the lake during a site visit in rainy conditions. The second culvert contains a perennial stream. An existing plunge pool is at the outfall on the lake side of the road. It appears that water is overflowing the plunge pool and creating a new secondary channel just to the south of the actual stream course. Where the stream meets the lake, a very wet area has developed, making it difficult to access the north fishing area from the center of the beach. A culvert crossing under the gravel parking lot access road is present on Vermont Natural Resources Atlas but was not observed in the field. Significant standing water was observed where the drainage swale meets the parking area road.

The stormwater observed in the drainage culvert along Lake Raponda Road that enters the unnamed perennial stream had significant sediment load on both the east side of Lake Raponda

Existing plunge pool, debris build up on left of picture, to be removed

Road upon outletting on the other side, within the existing rock lined swale and where it finally outlets into the Lake. This indicates that the swale is not sufficiently removing sediment as intended. Some soil in the swale was exposed due to rock being moved. A proposed plunge pool at the top of the swale will help reduce stormwater velocity and allow sediment to drop out before moving through the swale.

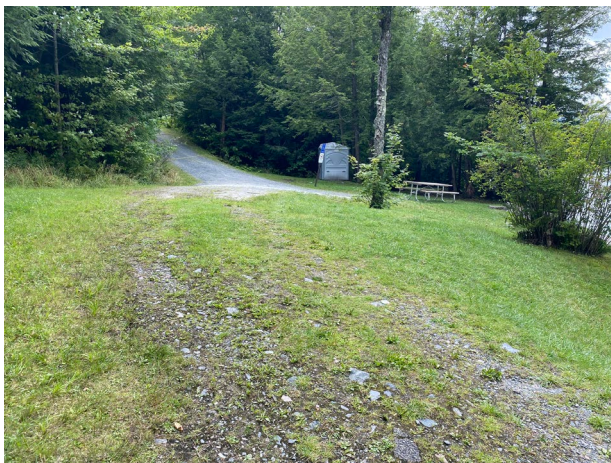
Erosion near both fishing areas at the water's edge was observed as well as adjacent to the existing stone steps between the two vegetated buffers. In the 2023 report from Lake Wise, erosion along the gravel access road had been observed, water bars along the road have since been installed and minimal erosion was evident during site visits made as part of this project.

Gravel access road and parking area

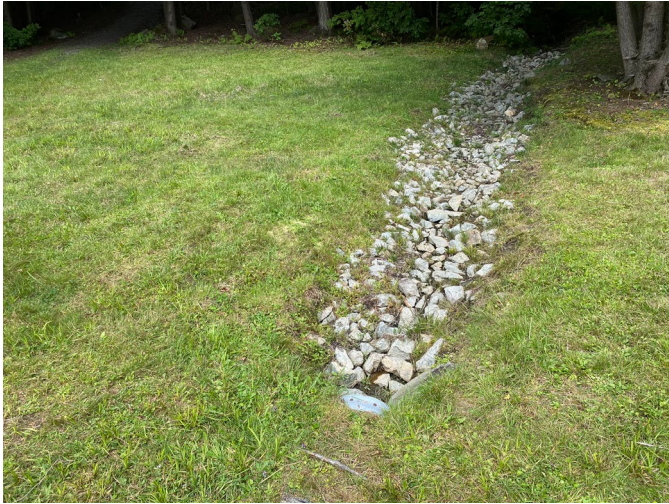
Two culverts were observed that direct water under Lake Raponda Road. The northern most culvert outlets into a rock lined swale near the north fishing area. Rocks in the swale were

Existing dry swale (rock lined swale)

The existing rock lined swale had numerous rocks dislodged and has minimal depth. A rebuilding of the swale is proposed to deepen the swale and add additional stone in order to reduce sediment load into the Lake.

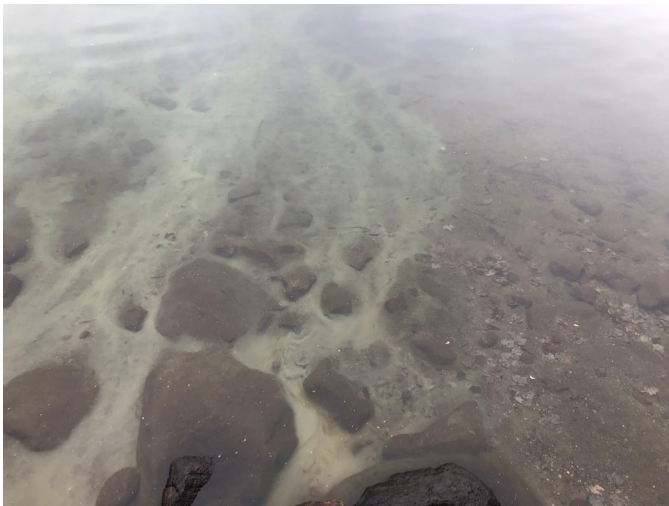
Sedimentation where dry swale outlets to lake (left side of photo)
