# **LAKE RAPONDA, GREEN MOUNTAIN BEACH SHORELINE EROSION CONTROL 30% DESIGN REPORT**

Client: Windham County Natural Resources  
Conservation District

Consultant: DuBois & King, Inc.

Date of Report: October 9, 2024

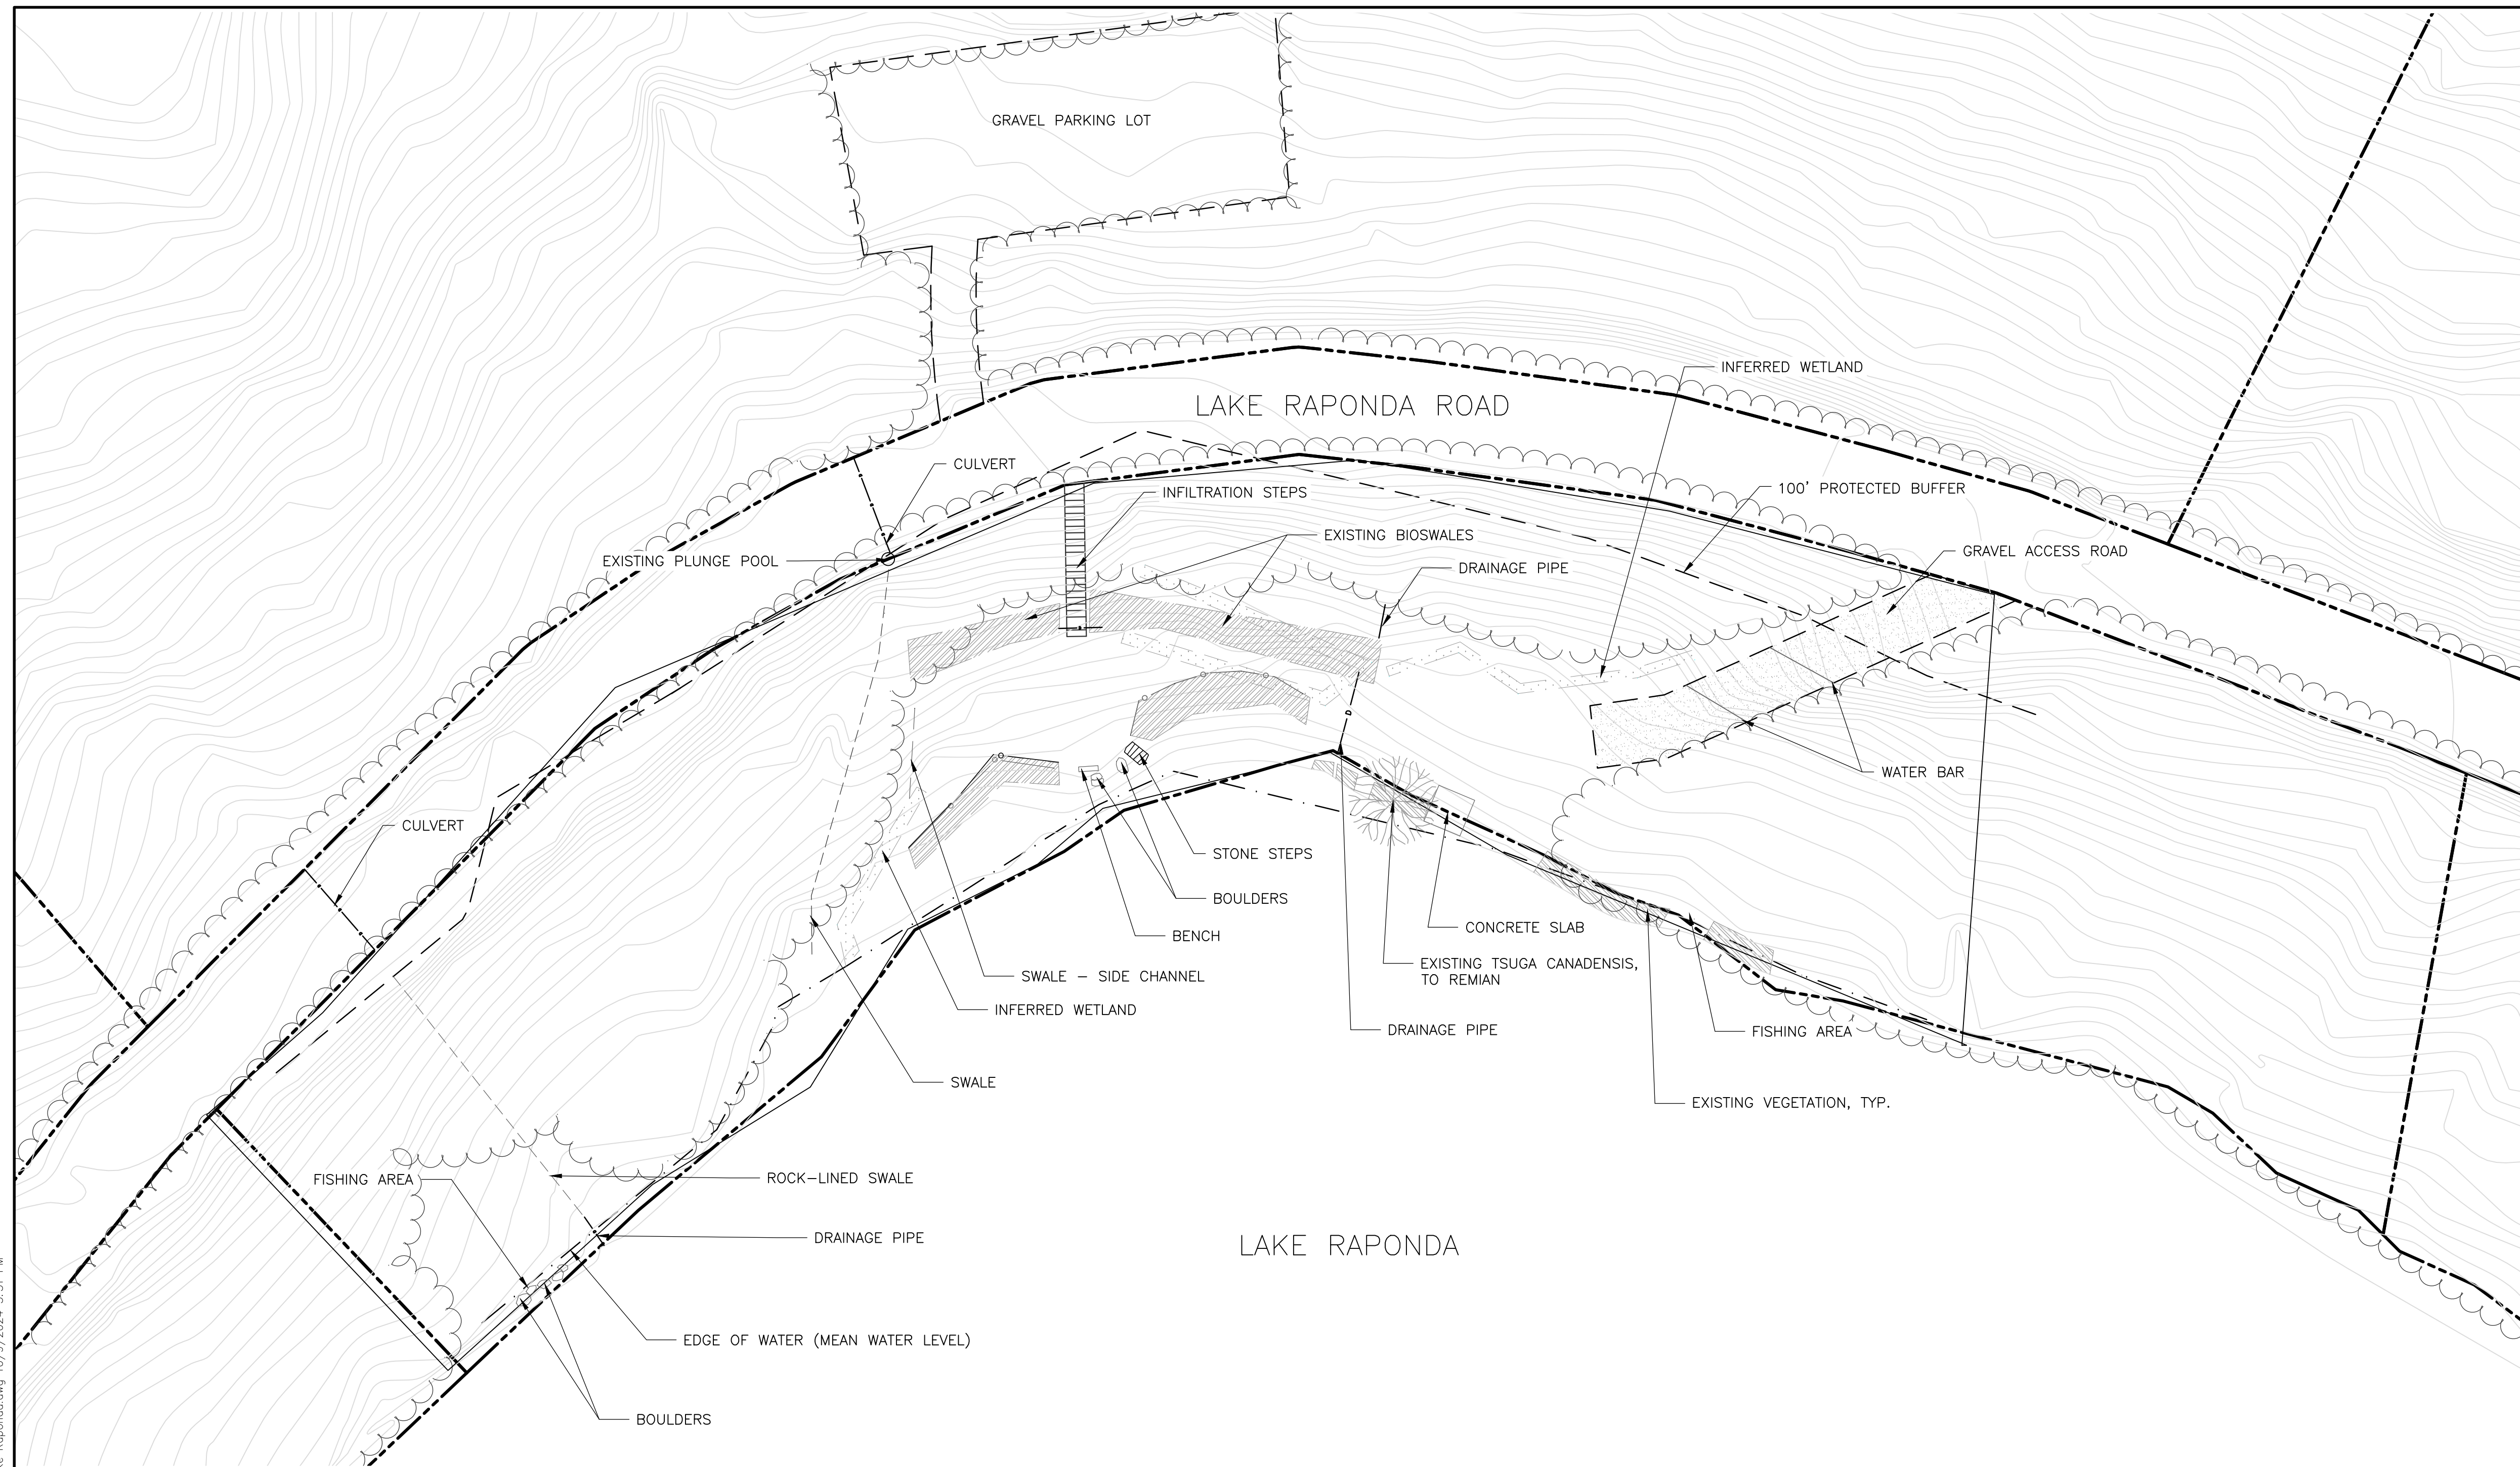
The existing bioswale overflows directly into the Lake and sediment was observed entering the Lake during rainy conditions. An overflow riser added to the existing outlet will allow more sediment to settle out prior to entering the outlet.

Sedimentation where dry swale outlets to lake (left side of photo)
